**Bureau of Reclamation  
Research and Development Office  
Science and Technology Program  
Project ID # 2621**

**Exploring Techniques to Reduce Lamprey and  
Salmonid Entrainment into Canals**

**Final Progress Report  
(from Yakama Nation)**

**Project Year 2016 - 2019  
January 26, 2016 – June 30, 2019**

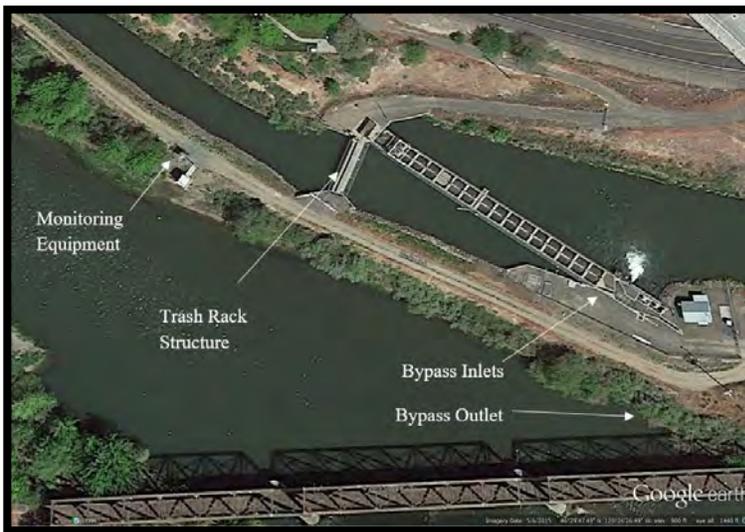
**Figure 1.1.** Illustration of Sunnyside Diversion channel and diversion infrastructure.

This section describes the PIT-tag detection array configuration and inventory of basic monitoring equipment that were purchased, fabricated, and installed by Yakima-Klickitat Fisheries Project personnel within the Sunnyside diversion channel infrastructure during the winter/spring of 2016. The equipment was used to monitor PIT-tagged lampreys and salmonids entrained into the canal from the mainstem Yakima River. Monitoring locations that were outfitted with PIT-Tag detection antennas include the canal trash rack structure, bypass inlets, and the bypasses outlet (Fig. 1.1). This equipment was scheduled to be operational for at least the project period (2016-2019), and YN Fisheries personnel monitored and maintained the installed equipment during this period.

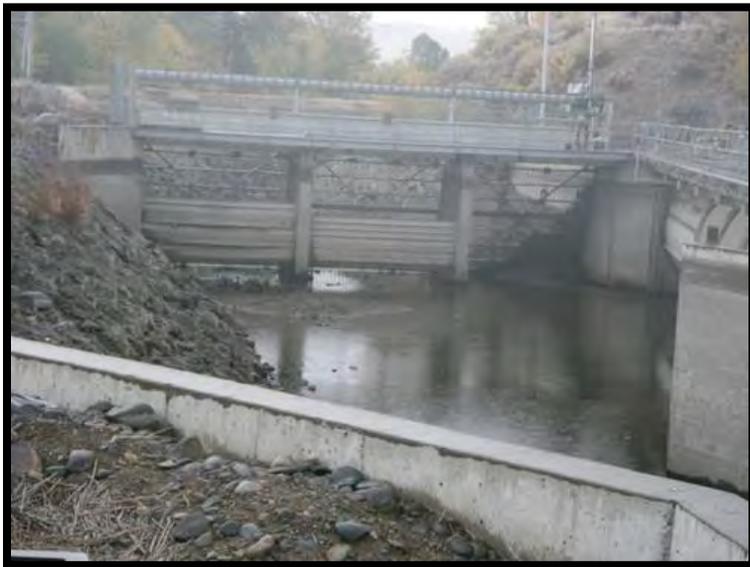
**Figure 1.2.** Sunnyside Diversion trash rack structure (looking upstream)

flashboards installed in the vertical concrete slots. As a result, this bay required three antennas to monitor the entire opening and water column from top to bottom. From the testing that was performed after installation, the read range off the coil was 27 inches with no dead spots.

There were two potential options for anchoring the antennas in place including: 1) the use of existing concrete vertical slots and 2) anchoring the antennas to the exterior walls on the downstream side of the structure. The vertical slots present the easiest option, but they are lined with channel iron, so there exists the potential for interference problems which could hinder the detection capabilities of the antennas. Due to interference problems that compromised the antennas substantially, the antennas were placed on the downstream side of the concrete bays using ½” anchor bolts to keep them in place. In summary the trash rack structure required seven antennas total, each having an independent antenna control node (ACN), and wire extending to the Master control terminal. The master control terminal was located in a Job box close to an AC power source to the west of the trash rack structure (Fig. 1.1).

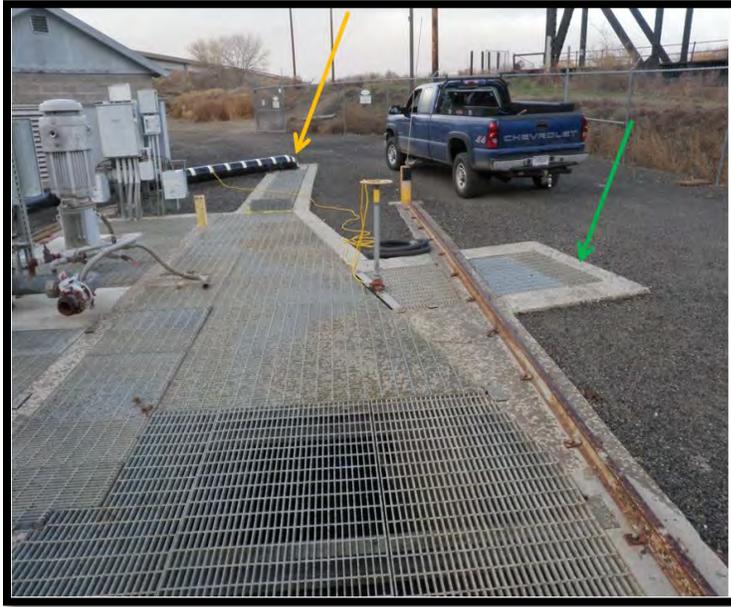
**Figure 1.3.** Bypass #1 (orange arrow) and #2 (green arrow)

There are two separate Bypass Inlets that required PIT-tag detection antennas (Fig. 1.3). Each of these are 2-3ft in width, and ~8ft in height. Like the trash rack structure, they have vertical concrete slots that can be used to slide the antennas in place. Due to the small width, a single antenna was used to monitor the entire water column for each of the bypass inlets. Thus, a total of 2 antennas and 2 ACNs were required for the Bypass Inlets. Wire extending from the antennas were placed in conduit, and buried beneath the surface substrate to avoid damage from foot and car traffic moving through the area.

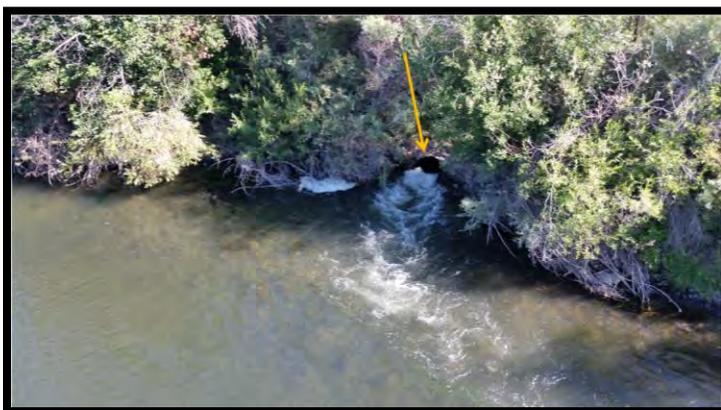
**Figure 1.4.** Sunnyside Bypass Outlet (yellow arrow) into the Yakima River

The two bypass inlets meet at an underground junction point before entering the river, thus creating a single bypass outlet. The outlet is no larger than 4 ft in diameter, so a single pass-through antenna was placed on the exterior part of the outlet (Fig. 1.4). The antenna was installed on the downstream end of the outlet pipe using a PVC/wooden frame anchored securely into the bank. Wires were housed in conduit and ran to the same Master Control box used for the trash rack structure and Inlet antennas.

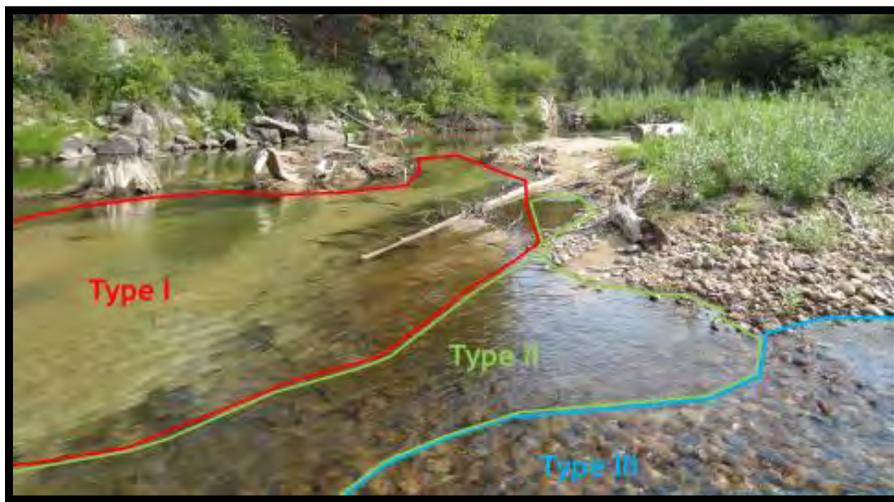
**Figure 2.10.** An example of Type I, II and III habitats used by larval/juvenile lampreys in a stream.

The following description provides an overview of methodology used to estimate lamprey numbers in Sunnyside and Wapato diversions between 2015 and 2018. Distribution of larval lampreys are typically very patchy and there are three types of habitat categories that help identify and qualify the quality of larval lamprey habitat (Fig. 2.10; Mullett & Bergstedt 2003; Slade et al. 2003; Moser et al. 2007). Type I habitat is preferred habitat which consists of a loosely compacted mixture of fine sediment (sand, silt, clay) and fine organic matter in depositional areas. Type II habitat is acceptable habitat which consists of shifting sand and/or a mix of fine and coarse substrates (typically with little fine organic matter). Type III habitat is unacceptable habitat which consists of all coarse substrate including gravel, cobble, boulder, and/or bedrock with no fine sediment. Our surveys focus primarily on Type I habitat where densities are typically much higher (~x10) than Type II habitat, but Type II habitat is also covered. See Task 6.5 for more information on habitat use.

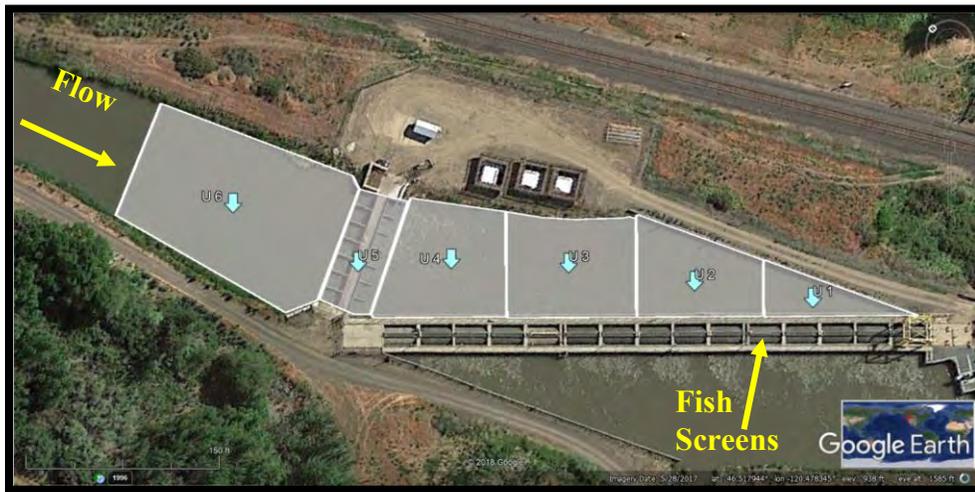
**Figure 2.11.** Delineated sections of the zone upstream of fish screens at Wapato Diversion (light grey polygons and blue arrows). Sections U1, U2, U3, and U4 divide the zone immediately upstream of fish screens. Section U5 surrounds the trashrack, and U6 is located in the upstream canal, reaching 50 m upstream of the trash racks (total project area length is 780 m).

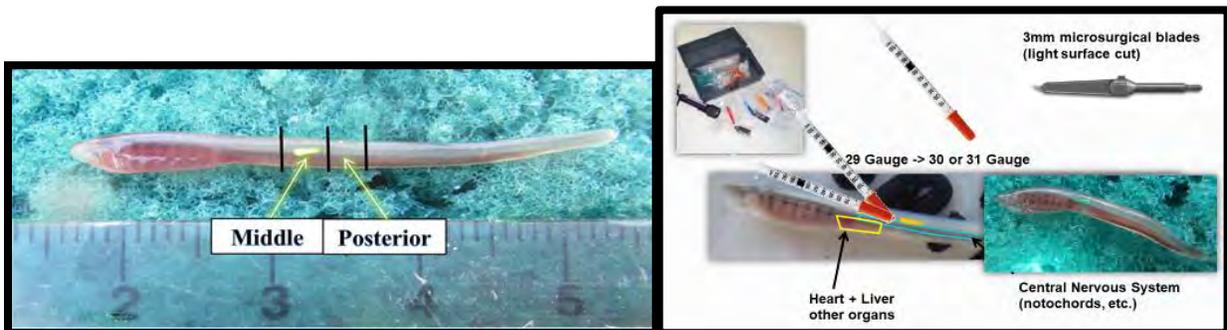
**Figure 2.13.** Available tagging regions on larval lampreys less than 50 mm (left photo). Shown is a larval lamprey (~38 mm) of an unknown species captured and tagged (middle region) at Wapato Diversion on October 16, 2014. For these smaller larvae, we recommend 1) making a light surface cut using a 3-mm microsurgical blade, 2) insert the needle through the surface cut at a high angle first to penetrate the skin, and 3) tilt the angle down to achieve a flat angle before sliding the needle in (right photo). Inserting the needle from the anterior end is recommended to avoid puncturing the heart and other critical organs just posterior to the last gill pore. A thinner needle is also recommended (30 or 31 instead of 29 gauge) for these smaller larvae.

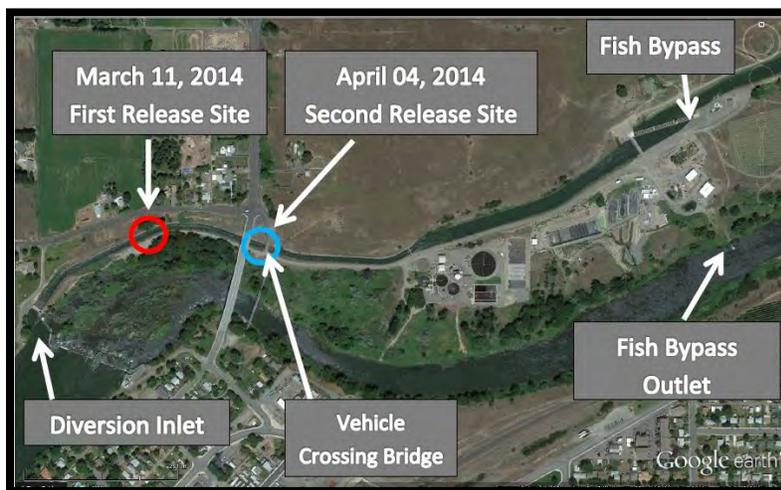
**Figure 3.3.** The two release sites into the canal upstream of the fish screens at Chandler Diversion (March 11, 2014 and April 4, 2014), relative to the diversion inlet, fish bypass, and the fish bypass outlet.

In 2014, 43 lamprey (8 juvenile and 35 larval Pacific Lamprey) were tagged and released near the upper end of the Chandler Diversion (Yakima River river km 75.4) between March 11 (n=7) and April 4 (n=36), 2014 (Fig. 3.3; Lampman & Beals 2015). These lamprey were all originally collected from Chandler Juvenile Fish Monitoring Facility (CJFMF). From these two releases, only two lamprey were detected; one juvenile Pacific Lamprey was detected 41 days later at CJFMF smolt bypass array whereas one larval Pacific Lamprey was detected 334 days later at CJFMF. This resulted in 12.5% and 2.9% detection rates for juvenile and larval Pacific Lamprey, respectively. All juvenile PIT tagged fishes returning from the canal back to the Yakima River would theoretically be detected when they pass through the smolt bypass array. As a result, we assume that only approximately 3% of the lamprey moving into Chandler Diversion are able to return back to the river system.

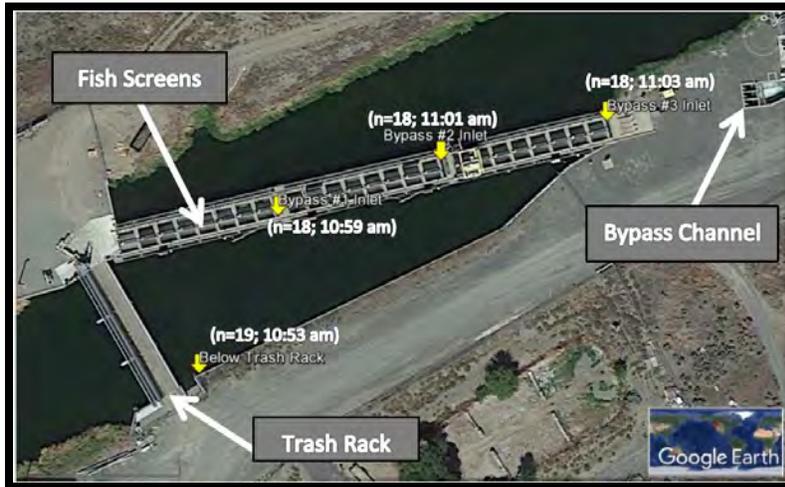
**Figure 3.5.** Overview map of Chandler Diversion and the four release sites on January 26, 2016. Release sample size and time of day are shown within the parenthesis next to the release location.

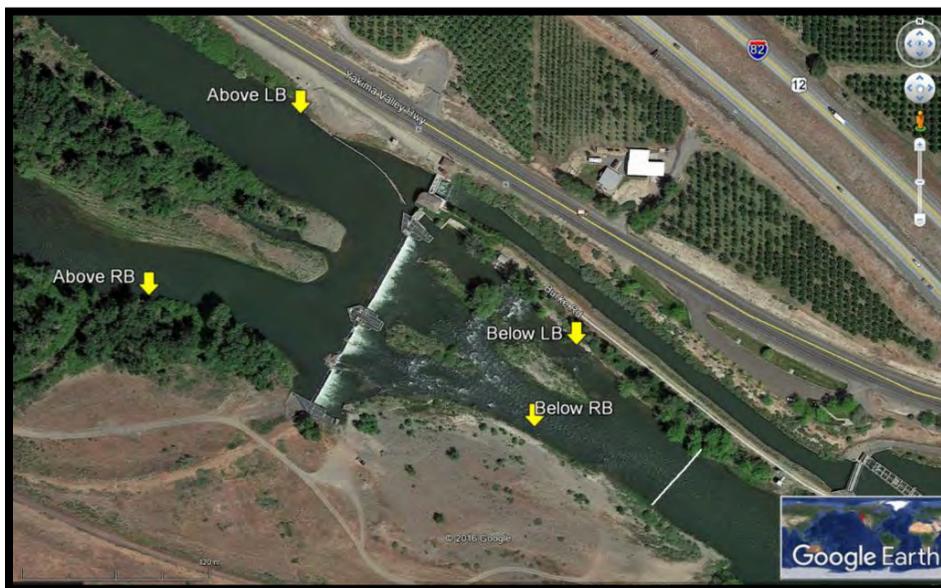
**Figure 3.6.** Overview map of Sunnyside Diversion and Dam as well as the four release sites from April, July, and October, 2016, located upstream [Above LB (left bank) and Above RB (right bank)] and downstream of the dam (Below LB and Below RB). The new channel spanning mainstem array is located downstream of all release sites and is displayed by the white line.

A total of 126 PIT tagged lampreys were released downstream of Sunnyside Diversion Dam on April 25, 2017, to test the detection efficiency of the PIT array on the mainstem Yakima River just downstream of the dam (see downstream release sites in Fig. 3.6). For this study we used primarily larval lampreys of both species (Pacific Lamprey and Western Brook Lamprey)

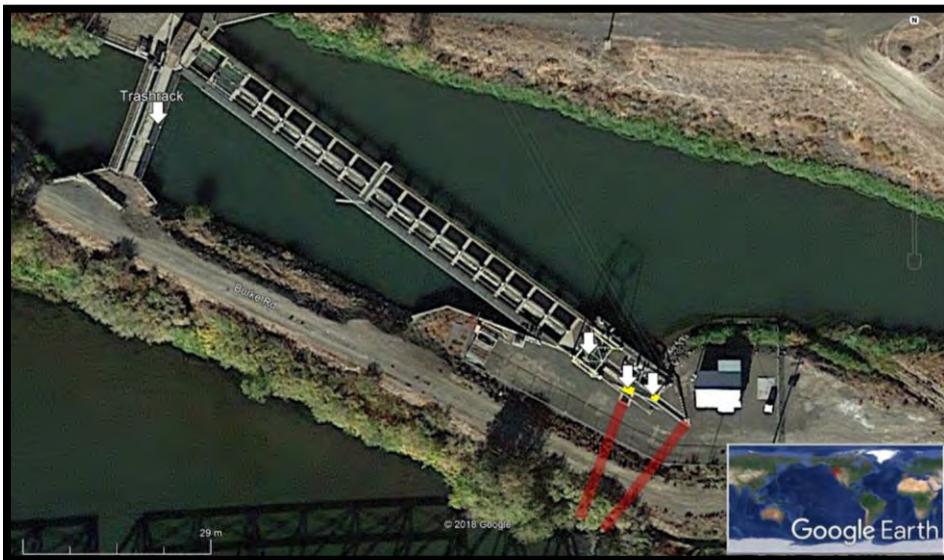
**Figure 3.9.** Overview map of Sunnyside Diversion fish screen area as well as the three release sites near the screens on October 13, 2017. One release was at the trashrack, another one was by the bypass inlet, and the third and fourth releases were directly in front of two bypass channels (red translucent polygons) that lead back to the mainstem Yakima River (two new PIT arrays were installed just downstream of these two locations as depicted by the yellow lines).

A total of 124 lampreys were also released inside the Sunnyside Diversion (Yakima River river km 171.3) in 2017 during the fall season just prior to irrigation shutdown in the Yakima River (Fig. 3.8 and 3.9). The releases were conducted on October 13, 2017, just prior to the irrigation shutdown. The goal was to test the detection efficiency of the new arrays installed within the irrigation diversion (by trash racks and bypass inlets and outlets). Lampreys were released in various parts of the irrigation canal to enhance our understanding of lamprey behavior within the diversion ( $n=41$  near canal inlet,  $n=41$  downstream of trash rack,  $n=22$  at bypass inlet,  $n=10$  at upper bypass outlet, and  $n=10$  at lower bypass outlet). For this study we used primarily larval lampreys of both species (Pacific Lamprey and Western Brook Lamprey) from the same sources as the 2016 releases. At this point in time (2017), only two arrays were in operation (one by the upper bypass inlet and one by the lower bypass inlet), but no detections were made by the lower bypass inlet.

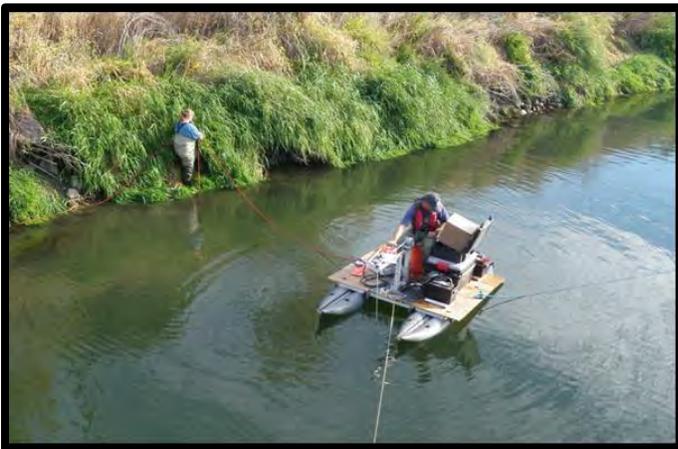
**Figure 3.10.** Bob Mueller (PNNL) operating the deepwater electrofishing platform at Sunnyside Diversion behind the fish screens.

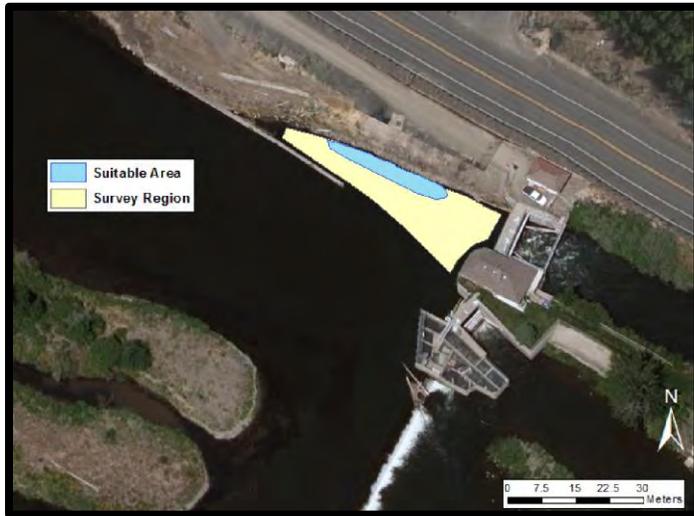
**Figure 3.12.** Sunnyside headgate region illustrating total survey region (yellow and blue polygons) and suitable region (blue polygons) from surveys conducted on October 21, 2015.

Within the Sunnyside headgate forebay region (Fig. 3.12), suitable substrates were estimated to be 93.4 m<sup>2</sup> and lamprey density was estimated at 2.5 fish per m<sup>2</sup>, which indicate ~232 lampreys occupying this region. The total survey area was 2,870 m<sup>2</sup> downstream of the screens and the total estimated survey area was 10.82 m<sup>2</sup> (Fig. 3.13). Seventy-five lampreys were observed

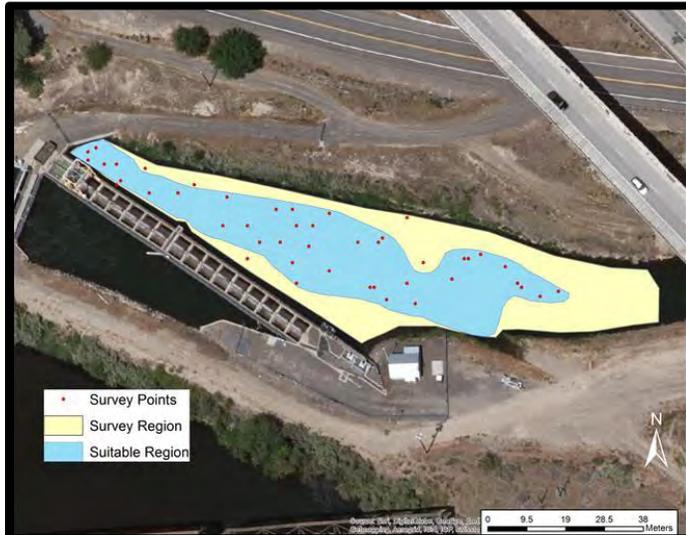
**Figure 3.13.** Sunnyside screen region illustrating sampling locations (red dots), total survey region (yellow and blue polygons) and suitable region (blue polygons) from surveys conducted on October 21, 2015.

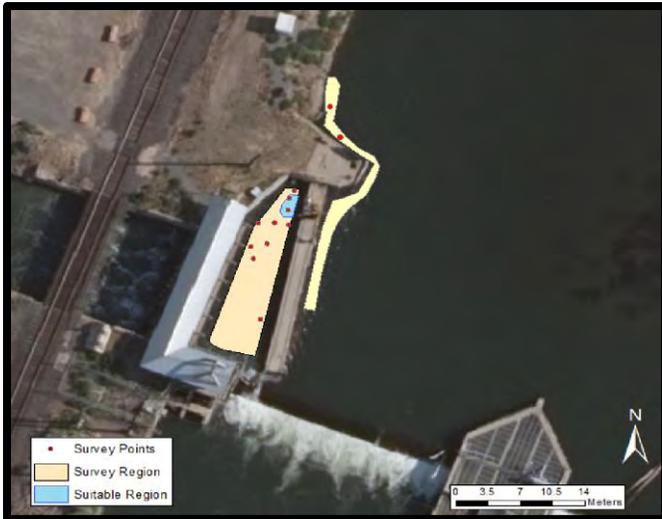
**Figure 3.14.** Wapato headgate region illustrating total survey region (yellow and blue polygons) and suitable region (blue polygons) from surveys conducted on October 15, 2015.

At the Wapato headgate only a small region (3.3 m<sup>2</sup>; Fig. 3.14) which was found in the upper portion adjacent to the log boom walkway was found to have suitable substrates. A total of 4 lampreys were observed in this region. Based on the surveyed area and a density of 4.2 fish per m<sup>2</sup>, a total of 14 lampreys might be expected to occur. At the screens forebay region (Fig. 3.15), 50 lampreys were observed across all size ranges. The total survey area polygon was 2,220 m<sup>2</sup> and the total estimated survey area was 10.41 m<sup>2</sup>. The suitable region encompassed 1,452 m<sup>2</sup> and an estimated 7.7 m<sup>2</sup> was surveyed with the DEP. The estimated density within the suitable region was 6.5 fish per m<sup>2</sup> and the total estimated lampreys that may be inhabiting this region was 9,404.

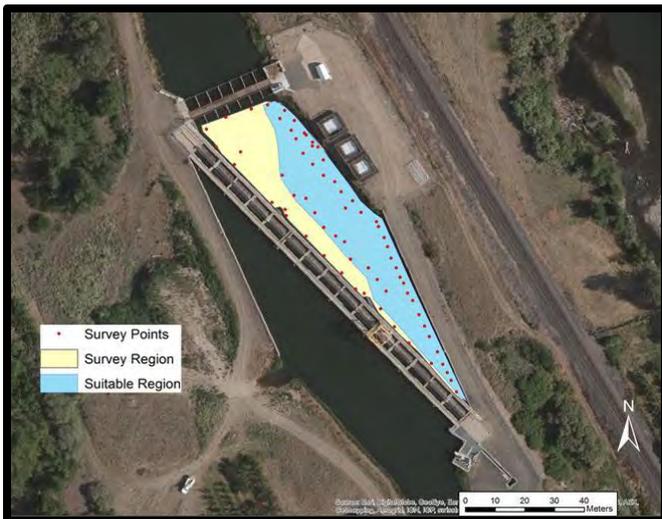
**Figure 3.15.** Wapato screen forebay region illustrating sampling locations (red dots), total survey region (yellow and blue polygons) and suitable region (blue polygons) from surveys conducted on October 15, 2015.

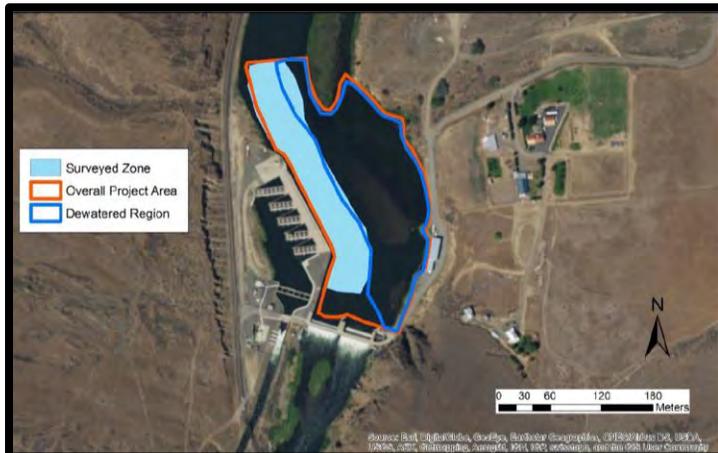
**Figure 3.19.** Roza Project area. Red line delineates the overall project area, light blue region delineates the zone that was surveyed and remains wetted year round, and blue line delineates the area that dries up during dewatering.

In 2015, PNNL and YN Fisheries staff also conducted deep water larval lamprey surveys near the Roza Dam Diversion Fish Screening Facility (Fig. 3.19) and at the Yakima River delta region (Fig. 3.20) to determine lamprey occurrence and provide a general assessment of substrate composition (Mueller 2017). Results from surveys indicated that very few larval lampreys are inhabiting deep water regions in Roza Dam forebay although suitable substrates are present and abundant; a total of four larval lampreys were observed in Type I and II substrates. Three of the four lampreys were found near the trash racks upstream from Screening Bay 5 at a water depth of 5.3 m, and the other was found ~515 m upstream from the facility at a water depth of 2.9 m. At the Yakima River delta, larval lamprey searches were conducted at three general areas consisting of the main river channel and delta regions to the north of the mouth. Most of the substrates in this region had significant macrophyte growth over soft sand/silt sediments reducing visibility. A total of three larval lampreys were observed in a relatively small region along the north section of the delta region in water depths of approximately 6 m in Type I and II substrates.

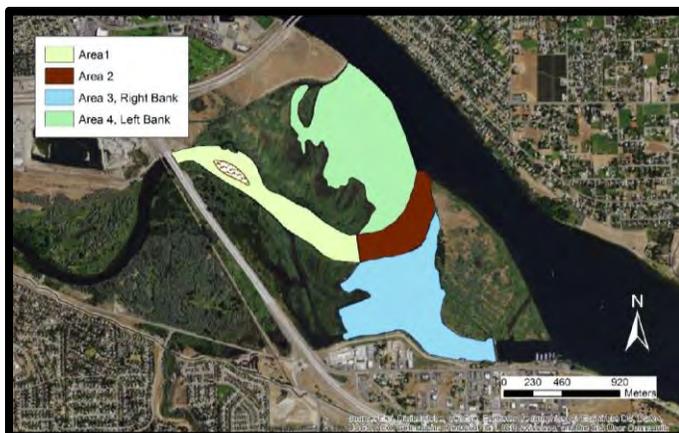
**Figure 3.20.** General survey regions near the Yakima River Delta.

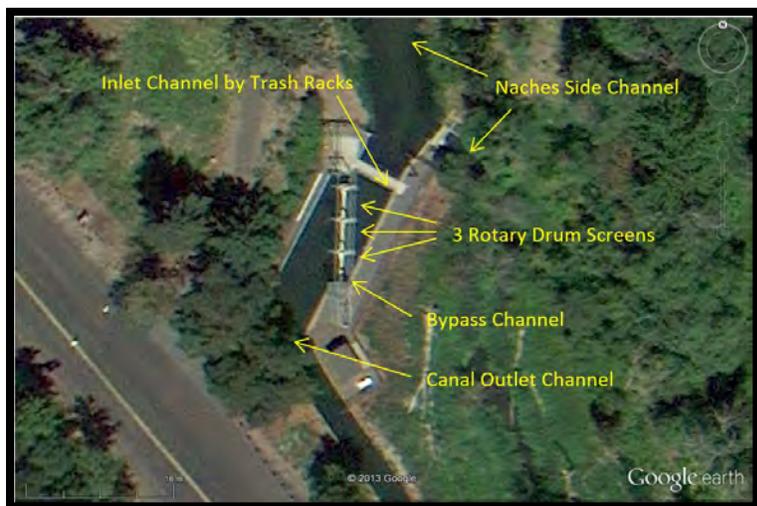
**Figure 3.21.** An aerial map of Congdon Diversion with labels for key components.

In 2014, a video monitoring and VIE tag study was conducted to improve our understanding of larval lamprey behavior within the diversion and in front of fish screens (Lampman & Beals 2014a). At Congdon Diversion (Naches, WA; Fig. 3.21 and 3.22), which has a rotating drum screen (woven wire mesh size of 3/32"; Fig. 3.23), we conducted a mark-release-recapture study on larval/juvenile lampreys, using a total of 190 Western Brook Lamprey (31-171 mm) and 1,256 Pacific Lamprey (7-25 mm). We conducted three types of test releases 1) trap efficiency release, 2) screen release for video monitoring, and 3) upstream release, in addition to the dewatered canal sampling. The main objective of this study was to understand the mechanism through which larval lampreys can pass the fish screens. The second research question we pursued was the “fate” of juvenile/larval lampreys that enter a diversion.

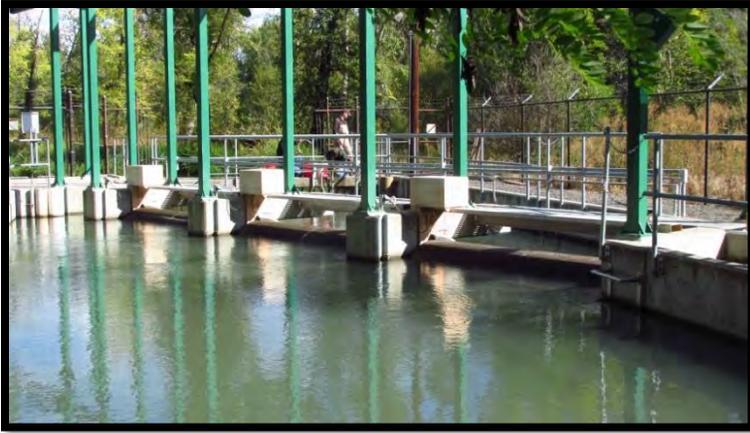
**Figure 3.22.** Looking upstream towards the three rotary drum fish screens at Condon Diversion.

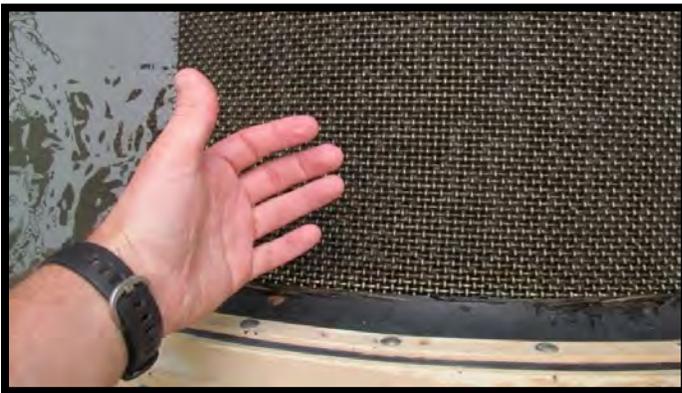
**Figure 3.23.** Woven wire mesh with a 3/32" (2.84 mm) opening at Congdon Diversion.

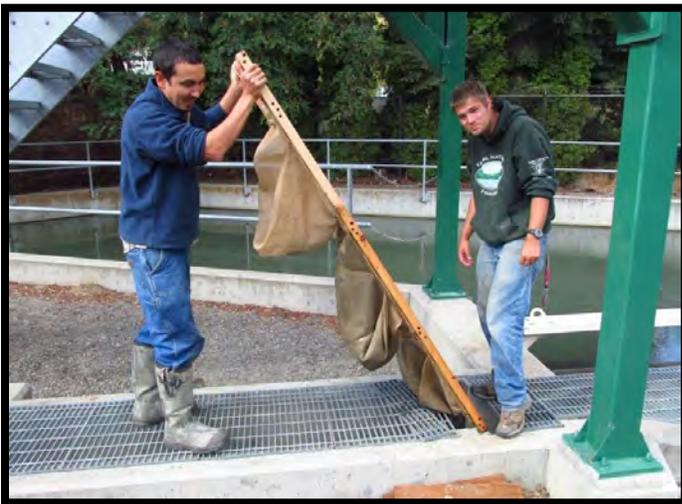
**Figure 3.24.** Inserting a custom made net for the trap efficiency test in the bypass channel.

The trap efficiency tests indicated that larvae can be effectively recaptured within various areas of the diversion (such as bypass and canal outlet channels) using plankton and custom-made nets (Fig. 3.24; Fig. 3.25). When 0+ age larvae were released in the canal, capture efficiency from the plankton nets was correlated with the flow rates (Fig. 3.26). With the respective increase in flow rates, plankton nets set in the upper water columns captured more lamprey while those in the lower water column only increased capture efficiency slightly with the respective increase in flow rates. At this size, lampreys in swift water may be migrating closer to the surface rather than the stream bottom in or near the thalweg channel.

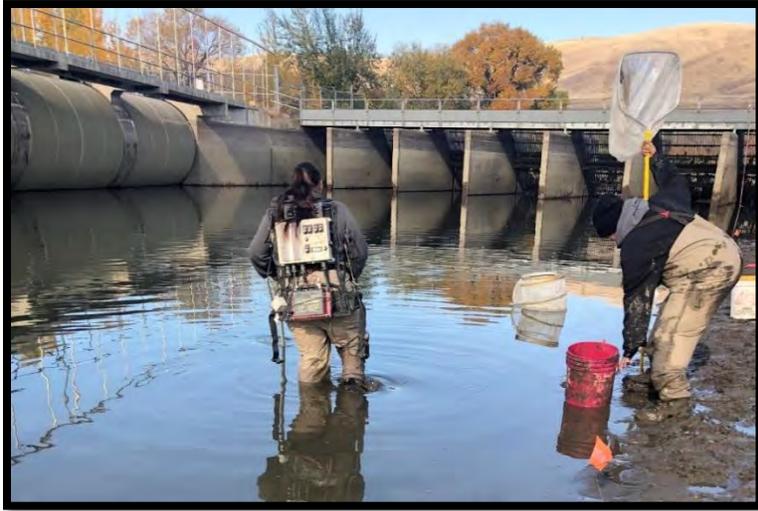
**Figure 4.1.** YN Fisheries crew conducting backpack electrofishing in Wapato Diversion upstream of the fish screens in winter of 2018. Dave’y Lumley (left) electrofishing while Shekinah Saluskin (right) assists with the fine mesh net and lamprey containers.

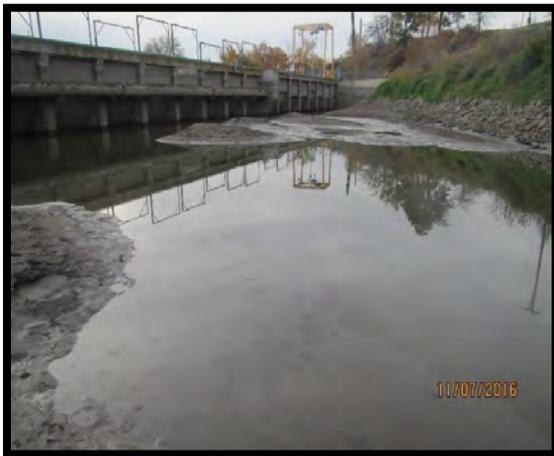
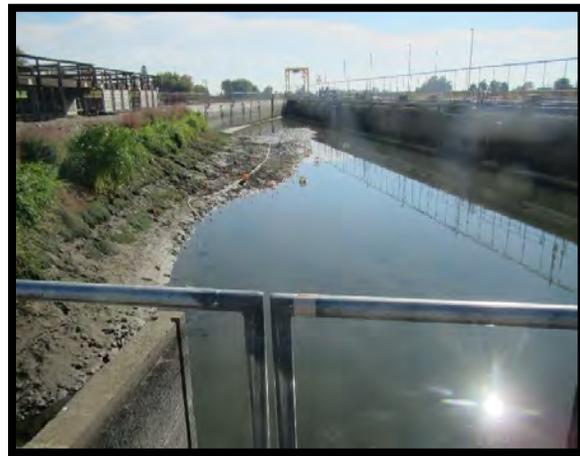
**Figure 4.2.** An example of open water areas that can be electrofished after stranded lampreys are recovered. In the left photo (Sunnyside Diversion), larval lamprey densities tend to be highest along the banks, especially towards the base of the taller mounds. In the right photo (Wapato Diversion), lamprey densities tend to be high along the bank, especially along the steeper banks.

In general, high densities of lampreys are typically found along the edge of the dewatered sediment and at the base of steep slopes (see Fig. 4.2). We recommend that rescue surveys focus primarily on wetted Type I habitat, which is preferred by larval lampreys and consists of fine sediment (sand, silt and clay) and/or detritus (fine and coarse organic matter). Type II habitat consists of a mix of fine and coarse sediment and can be surveyed as well, but densities tend to be lower (typically 10% of Type I). To preserve water clarity and reduce long-term exposure to electricity, we recommend the use of single passes at a steady pace ( $\sim 1$  min per  $\text{m}^2$  of habitat covered). This is important especially in high density areas. The shock time, shocked area, and number of lampreys removed is recorded for each pass to provide density and catch per unit effort (CPUE), which helps guide the areas to prioritize. It is important to assess all potential locations so removal efforts can focus on the highest densities of lampreys first. All captured lampreys are immediately placed into flow through mesh baskets until counting, identification, and release takes place (or until density is too high within mesh baskets).

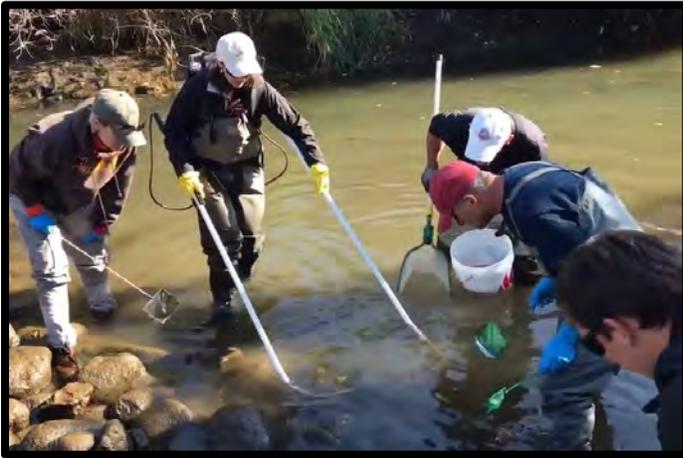
**Figure 4.3.** Example of conditions (high turbidity and high density of lampreys) in which “blind netting” can be effective in rescuing lampreys. Netters with large size nets can scoop the area surrounding the electrofishing probes back and forth to capture any invisible larvae that emerge from the fine sediment.

“Blind netting” is a useful technique that could be used in high turbidity and low visibility water conditions whereby the netter(s) scoops through the electrofished water to capture anything that may be in the turbid water even without any direct observation of lampreys (Fig. 4.3). In many cases, the water clarity during a diversion salvage will become turbid, and it will become very difficult to see larval lampreys during electrofishing (Fig. 4.4). Blind netting consists of a second person (netter) waving a fine mesh net through the water (near the bottom) during the electrofishing survey to capture escaping lampreys that are not seen. This method is particularly effective in shallow water (or isolated pools). This method can capture all size classes of

larval/juvenile lampreys, although it appears to be most effective in capturing small lampreys (< 50 mm) as they swim much slower when they escape the sediment, and are easily captured in the net. Perform the blind netting technique throughout the survey area, but focus in areas where larvae densities are expected to be high (such as edges of wetted habitat, base of steep slopes, or along concrete walls where lampreys seem to congregate). In high density and high turbidity water conditions and at appropriate water depth (typically 16” or less), this method can be quite effective, allowing surveyors to continue to electrofish and rescue lampreys despite the high turbid and low visibility conditions. However, many lampreys can still be left behind with this method and care is needed to ensure you do not electrofish lampreys in one area over and over (best to maintain a  $1 \text{ m}^2 \text{ min}^{-1}$  electrofishing pace to stay on the move).

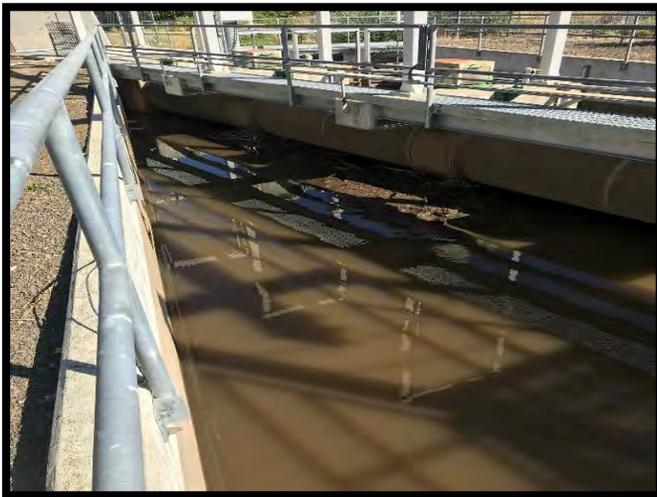
**Figure 4.4.** Highly turbid water encountered during a lamprey salvage operation at Upper WIP Diversion on Ahtanum Creek in July, 2019. Blind netting was used to capture larval lampreys during this salvage operation.

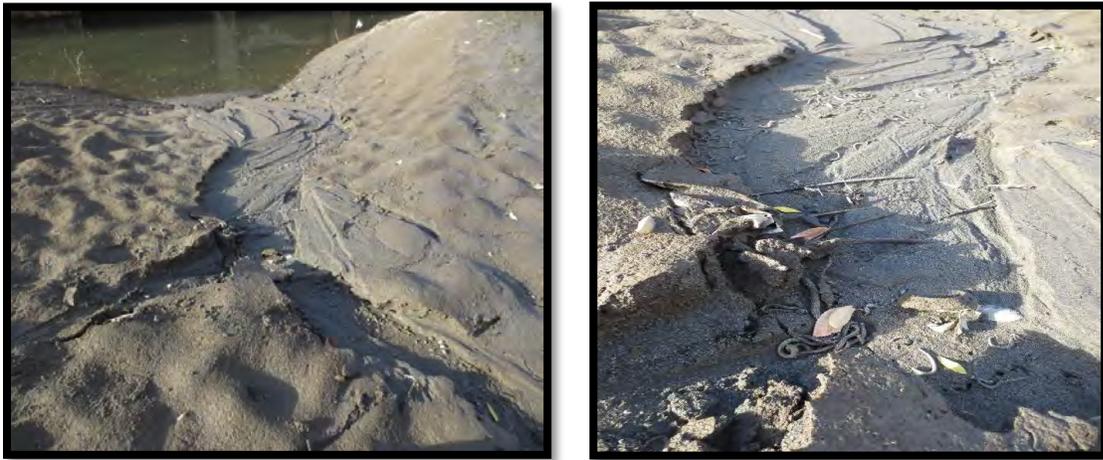
**Figure 4.6.** Desiccated larval lampreys on top of dewatered sediment at the base of a slope at Sunnyside Diversion shortly after dewatering in 2017. The left photo shows the sediment contour (overview of the steep slopes). The right photo shows about 100 dead larval lampreys accumulated at the low gradient area (zoomed in view of the left photo). A higher number of lampreys are often found in these types of depositional areas with debris (branches, rocks, etc.); lampreys are often found underneath the debris.

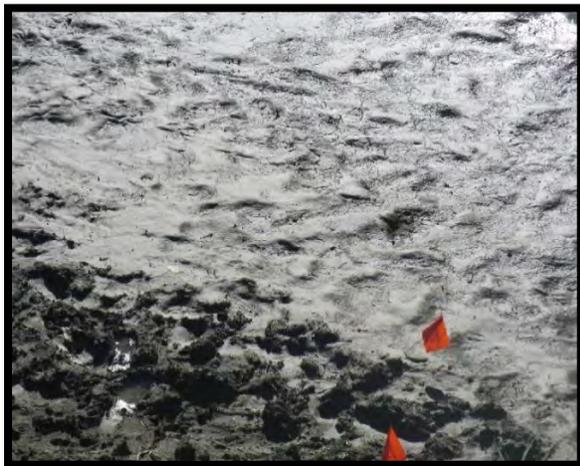
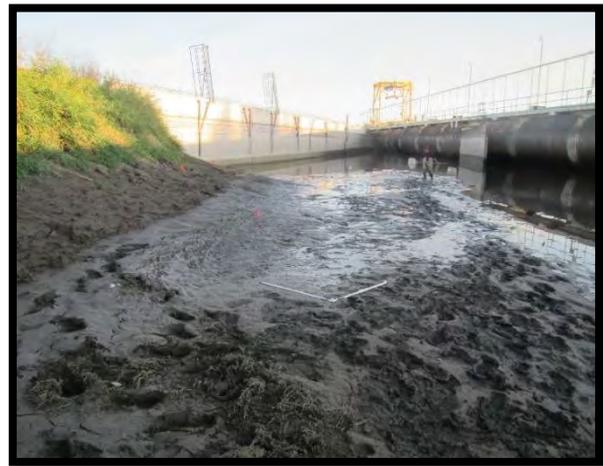
**Figure 4.7.** Examples of visibly dry areas where larval lampreys were still concealed under the surface at Wapato Diversion (October 23, 2017). Water was poured over these areas, electrofished, and densities of 20-30 live larvae m<sup>-2</sup> were observed in many areas (even though no lampreys were emerging on the surface of the sediment). In the back of the right photo, you can see the moist sediment (shiny/reflective areas in the photo) where 70-80 lampreys m<sup>-2</sup> were observed.

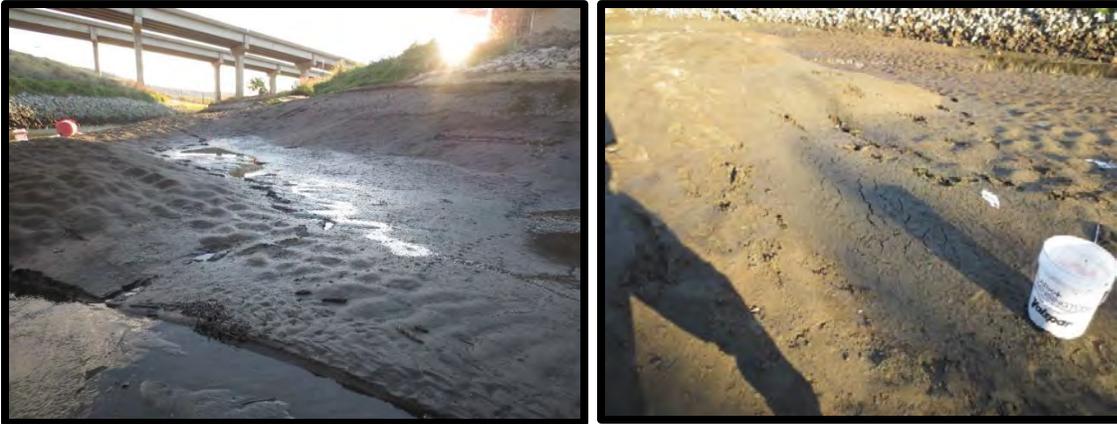
**Figure 4.8.** Examples of visibly dry areas where larval lampreys could still be concealed under the surface of the sediment where dry shocking is effective at Sunnyside Diversion (November 1, 2017). In the left photo, water could be poured on the outside edges of the visibly wetted surface as larval lampreys likely have congregated at the bottom of the slopes. In the right photo, pouring water on the flat surface (with small mounds) or over the cracked sediment at the bottom of the hill would be great places to perform the dry shocking method.

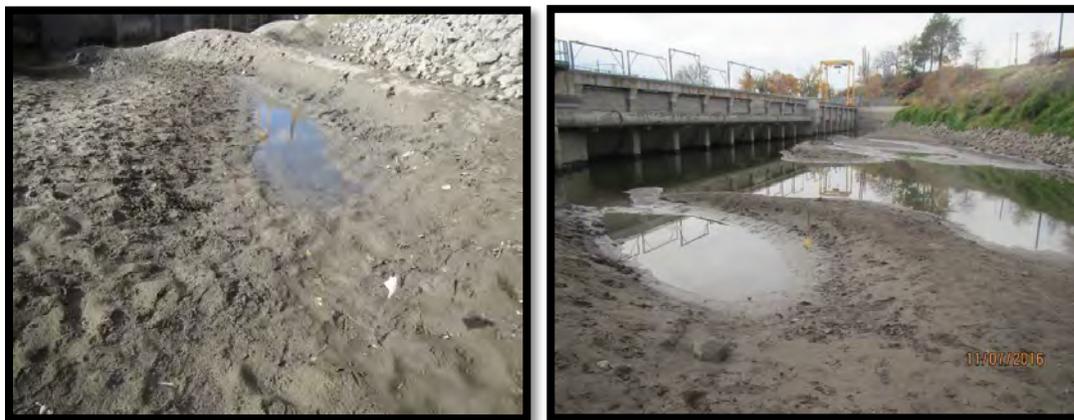
**Figure 4.9.** An example of isolated pools that held high densities of larval lampreys at Sunnyside Diversion in 2016 (~100 lampreys m<sup>-2</sup>). The left photo is an example of a small, shallow isolated pool (high priority). The right photo is an example of a large isolated pool (that would be second in priority to the smaller pool).

Some isolated pools (small pools of water isolated by dry habitat) provide temporary refuge to large numbers of lampreys (Fig. 4.9). Isolated pools located in prime habitat tend to have very high densities of lampreys, and should be the initial focus of electrofishing efforts. Similar to the bank salvage methods, each isolated pool should be assessed for lamprey numbers before focus is placed on one pool (to make sure efforts are focused on the highest densities of lampreys to be rescued). Remove lampreys from isolated pools before they dry up (focusing on pools with higher densities of lampreys). The size of the isolated pool is another factor to consider when prioritizing (i.e. small pools tend to dry up first). Water could be poured over these isolated pools to help increase the electrofishing efficiency as well as to prolong their survival. Whenever possible, electrofishing should occur in single passes (at a rate of 1m<sup>2</sup> per minute) to limit long-term exposure to electricity potentially leading to electronarcosis.

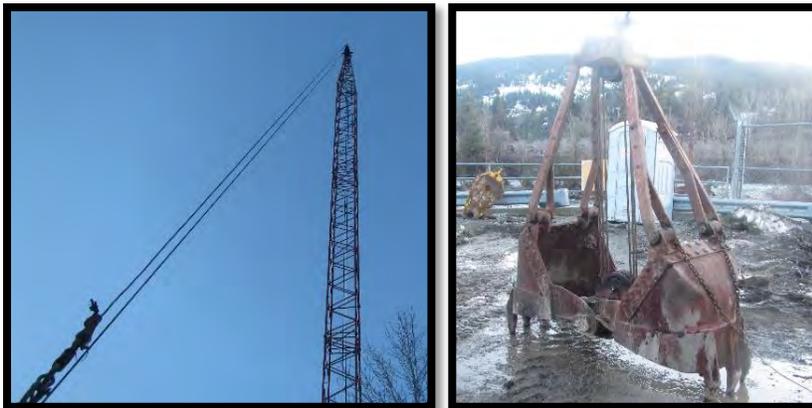
**Figure 4.11.** The 150-ft tall crane (top photo) and the dredge grabber (bottom photo) used for the dredging operation at Dryden Diversion forebay.

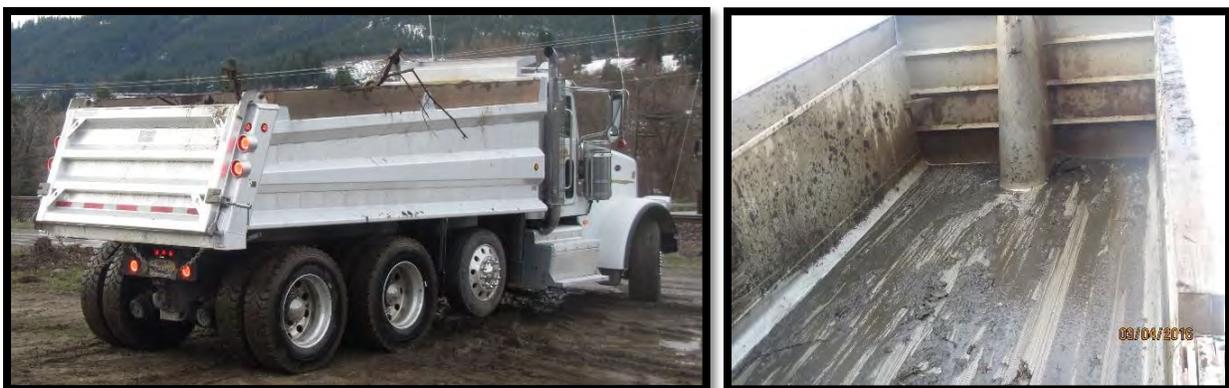
**Figure 4.12.** Custom-made waterproof dump truck owned by Wilsonville Concrete Products (Wilsonville, OR). Overview (left photo) and the inside (right photo).

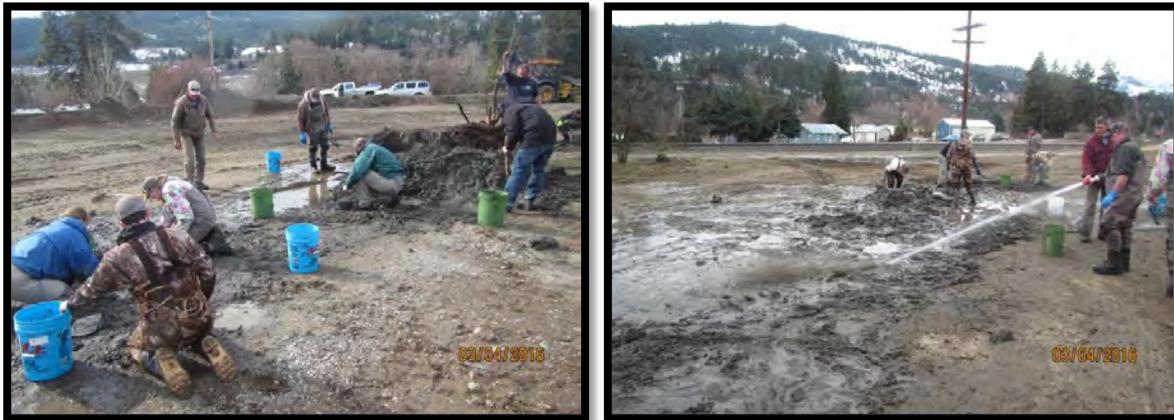
**Figure 4.13.** Efforts to rescue larval lamprey from discarded material included searching the sediment surface by hand (top photo), and use of a fire hose to disturb and spread sediment to expose burrowed lamprey (bottom photo).

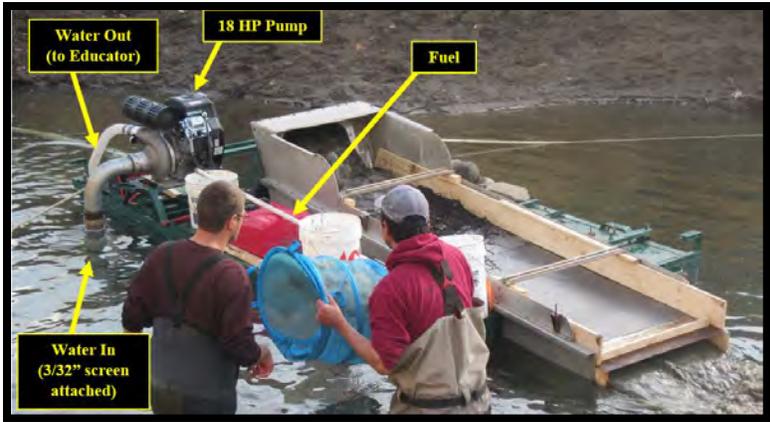
**Figure 4.14.** Side angle view of the sluice box system with labels for pump and associated parts.

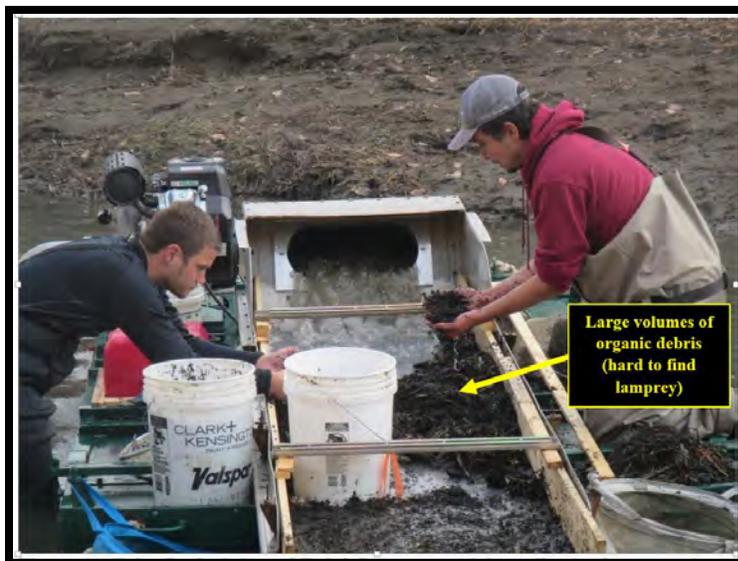
**Figure 4.16.** Tyler Beals (left) and Ralph Lampman (right) collecting lampreys from the sluice box during salvage operation on November 17, 2017. The organic debris built up quickly, and sifting through the large amounts of organic debris to find lampreys proved to be time consuming and difficult.

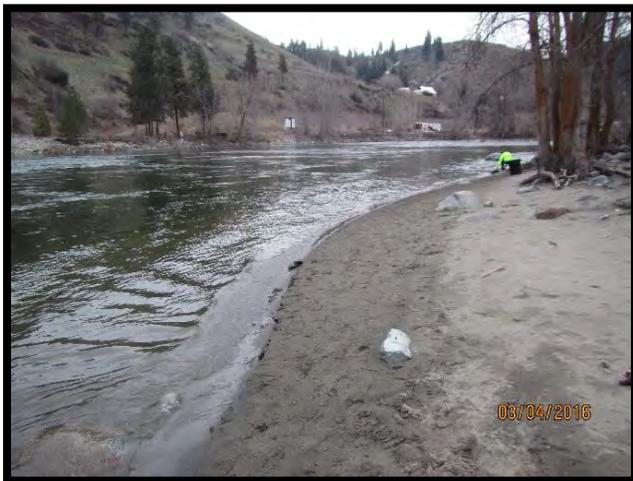
**Figure 4.22.** An example of a release location with Type I/II habitat selected for lamprey rescued from Dryden Diversion.

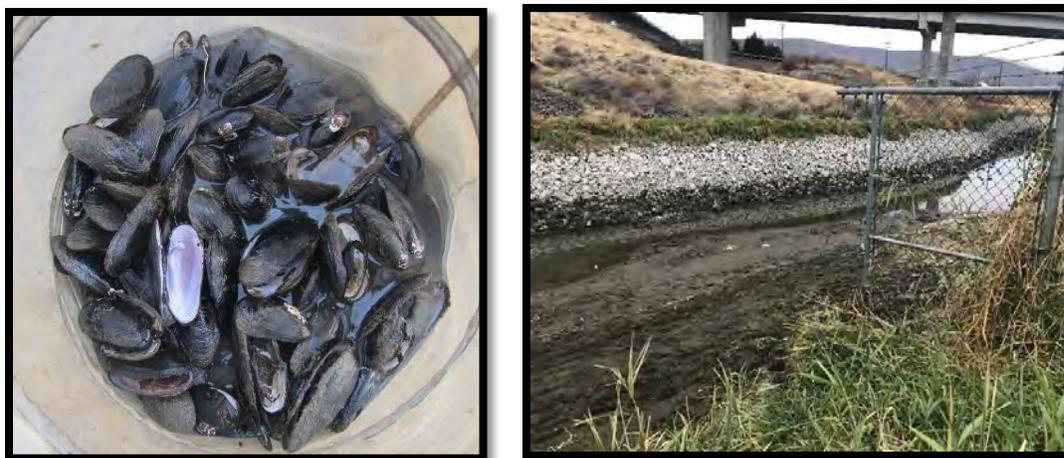
**Figure 4.23.** Western Pearlshell mussels collected from the canal downstream of the fish screens at Sunnyside Diversion in 2017. The left shows many live and dead mussels collected from the canal (up to 6" long). The right photo shows the canal where the mussels were collected after dewatering.

Fisheries has encountered high densities of freshwater mussels (up to 6” at their longest length) upstream and downstream of the fish screens at Sunnyside Diversion on the Yakima River (primarily Western Pearlshell species) (Beals & Lampman 2018d; Beals 2019). Freshwater mussels have also been encountered in other diversions, such as Wapato and Ellensburg Mill diversions, albeit lower numbers. The mussels found downstream of fish screens were likely entrained during the larvae/glochidia stages and subsequently reared in the irrigation diversion water as subadults/adults (Fig. 4.23). There is some evidence that a portion of these mussels can

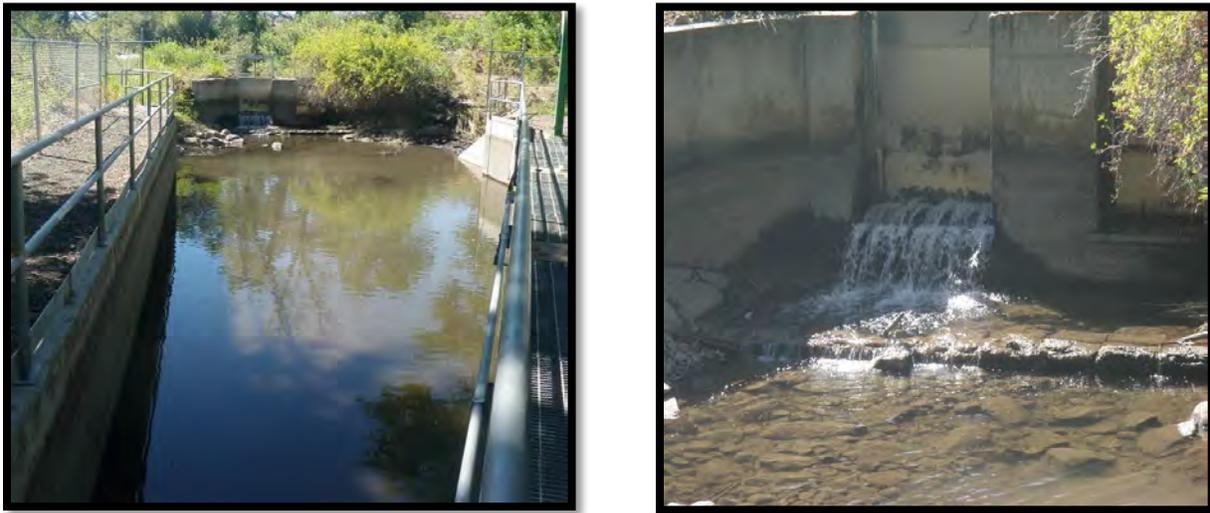
**Figure 5.6.** The left photo shows the area between the headgate (upper left-center) and the fish screens at Bachelor-Hatton Diversion with a small amount of water flowing in through the headgate. The photo on the right shows  $\sim 150$  gallons  $\text{min}^{-1}$  entering the screening area (to provide flow to entrained lampreys).
