**Bureau of Reclamation  
Research and Development Office  
Science and Technology Program  
Project ID # 2621**

**Exploring Techniques to Reduce Lamprey and  
Salmonid Entrainment into Canals**

**Final Progress Report  
(from Yakama Nation)**

**Project Year 2016 - 2019  
January 26, 2016 – June 30, 2019**

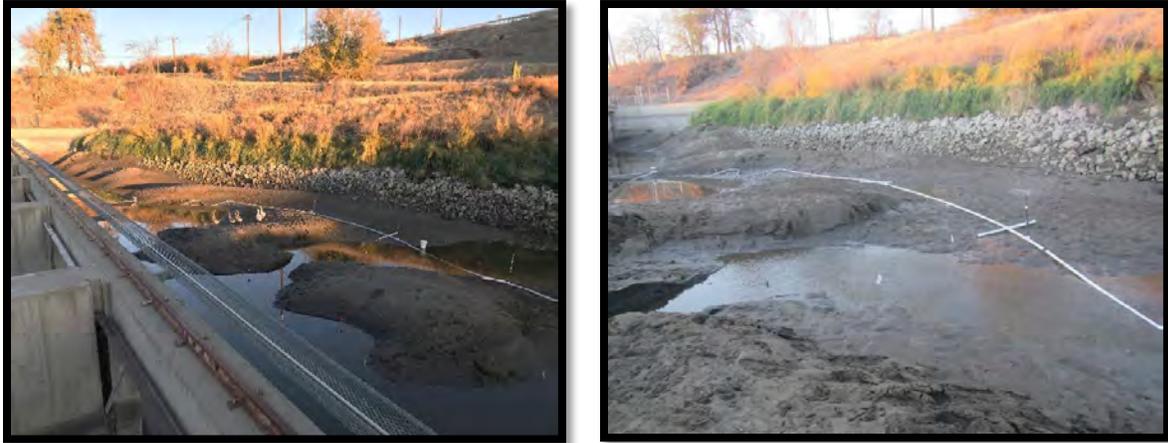
**Figure 5.8.** Overview of the sprinkler system operation downstream of the fish screens at Sunnyside Diversion immediately after dewatering of the key larval lamprey habitat occurred. Part of the sprinkler system was able to cover the high density isolated pools.

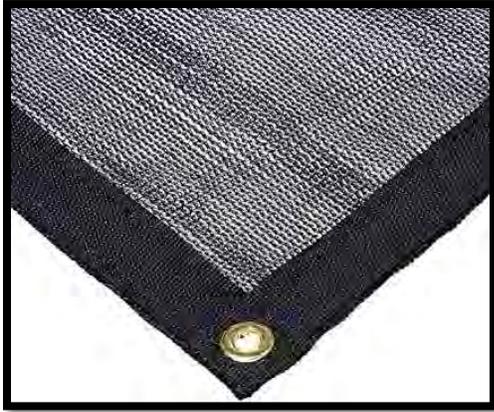
**Figure 5.9.** An example of a polymesh tarp material that could be used for covering dry banks with a high chance of predation.

One proposed method to help protect exposed larval lampreys from predation after dewatering (when personnel are not available, and throughout the evening hours) is to place a 1/8” or smaller mesh net over the high density dry banks to prevent predation. This may be most effective if used in conjunction with the water sprinkler setup, which will help them traverse to the water's edge. By coupling this with the sprinkler system, it will not only limit predators' ability to pick up exposed lampreys but also allow water to seep through the holes and keep lampreys moist/wet. The netting material does not have to cover the entire dry sediment area, but can be used in high density critical areas. It can be placed at the base of concave surfaces, bottom of steep slopes, or placed over isolated pools (that may dry up), and other areas where larval lamprey densities were observed (or predicted) to be the highest on (or within) the dry bank. One potential option for netting material is grass seed netting, which comes in a variety of sizes, can absorb water to stay moist, and is biodegradable. Reusable options include poly mesh tarps (such as 70% shade; Fig. 5.9).

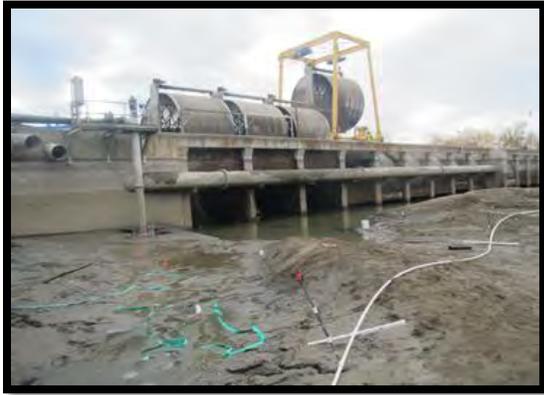
**Figure 5.10.** Screen washing activity at Sunnyside Diversion in November, 2018. Water turned very turbid, which made observing lampreys during electrofishing extremely difficult.

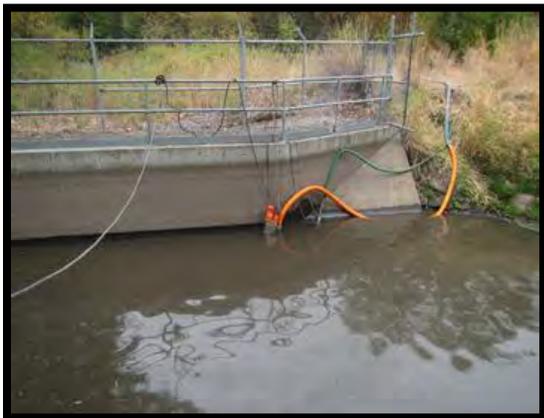
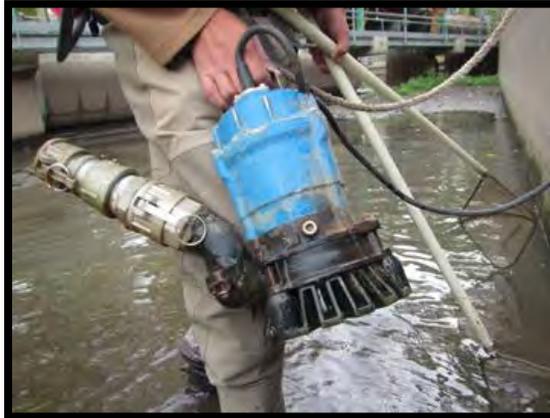
**Figure 5.11.** The left photo shows small (50-300 gallon min<sup>-1</sup>) industrial pumps removing water from Bachelor-Hatton Diversion in October, 2016. The right photo shows the intake screening system on one of the pumps which is designed to prevent entry of large debris, but not lampreys.

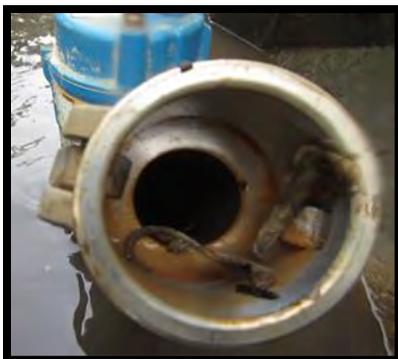
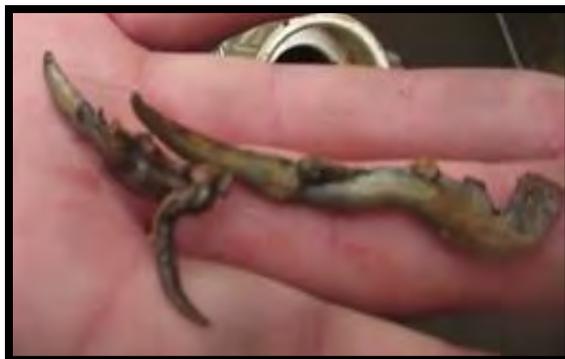
**Figure 5.12.** Mutilated lampreys found within the camlock that connects pump to the discharge hose at Bachelor-Hatton Diversion on October 16, 2015. C

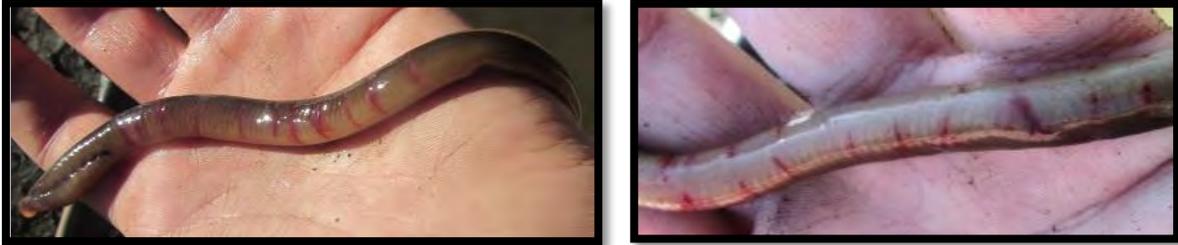
**Figure 5.13.** Injured larval lampreys found at Sunnyside Diversion in previous years, which are suspected to be caused by either unscreened pumps or dredging.

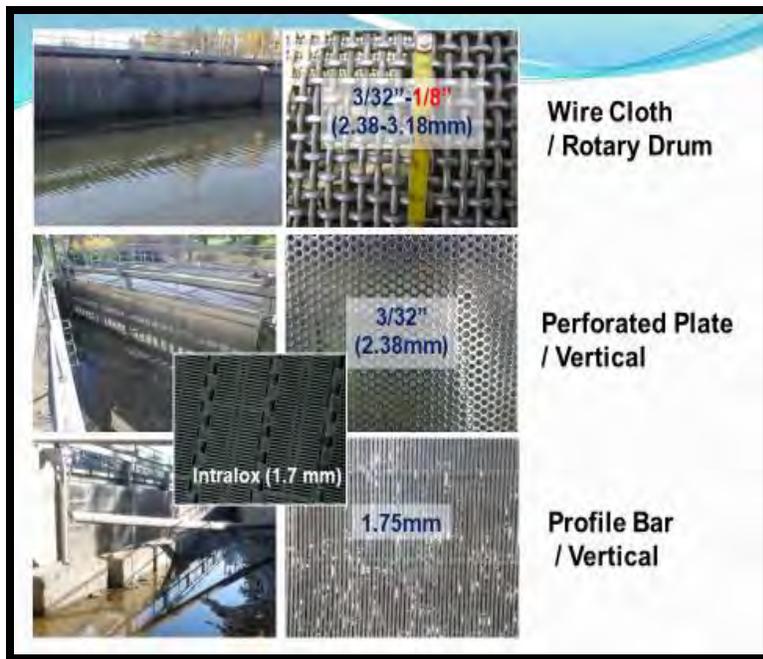
**Figure 6.3.** Photos displaying the four main types of screens and examples of facilities that use these screens. The NOAA Fisheries salmonid criteria for the mesh opening size are also displayed for each screen type.

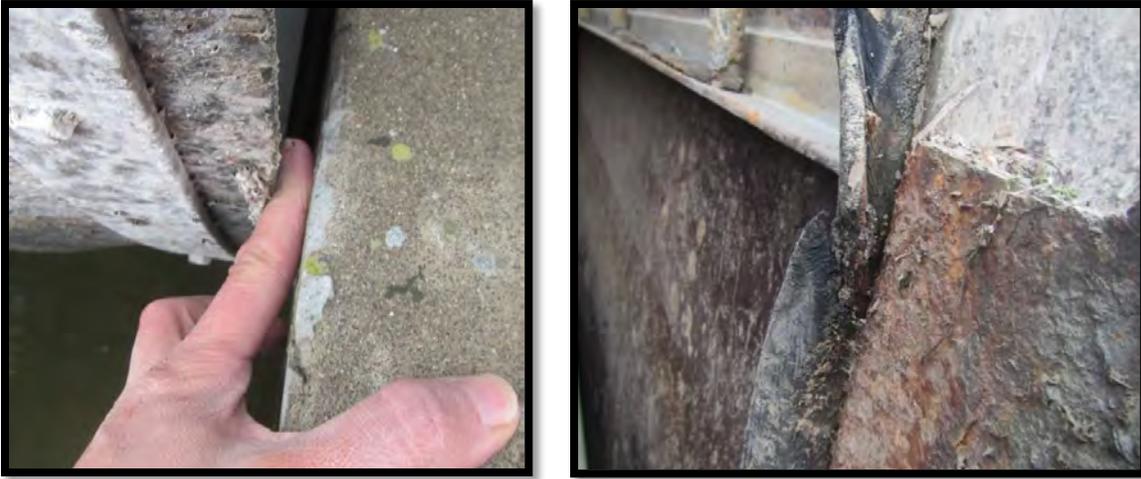
**Figure 6.11.** Examples of gaps/tears observed at Sunnyside Diversion during winter of 2013. The size of gaps ranged from 5-14 mm. The left photo shows a gap with a 14-mm opening. The right photo displays a damaged rubber seal, resulting in a larger opening.

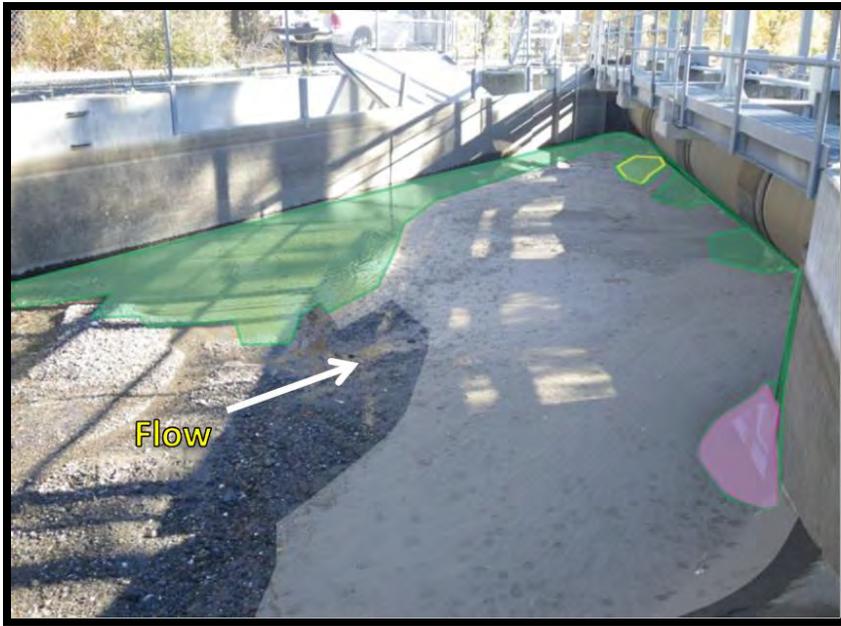
**Figure 6.14.** A representative photo showing observed dry Type I and II habitat area (grey color polygon), wetted habitat area surveyed (green color polygon), and a typical high density habitat area for larvae (pink color polygon) and transformers (yellow color polygon) from Taneum Diversion.

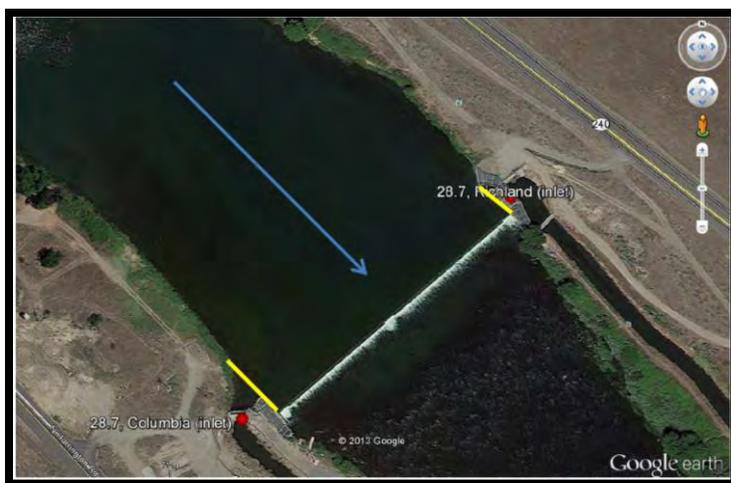
**Figure 6.19.** Columbia Diversion (left) (inlet angle = 90 degrees, canal width = 8 m) and Richland Diversion (right) (inlet angle = 90 degrees, canal width = 9 m) on the Yakima River. The blue arrow displays the thalweg flow direction and the yellow lines display the general orientation/angle of the headgate structures.

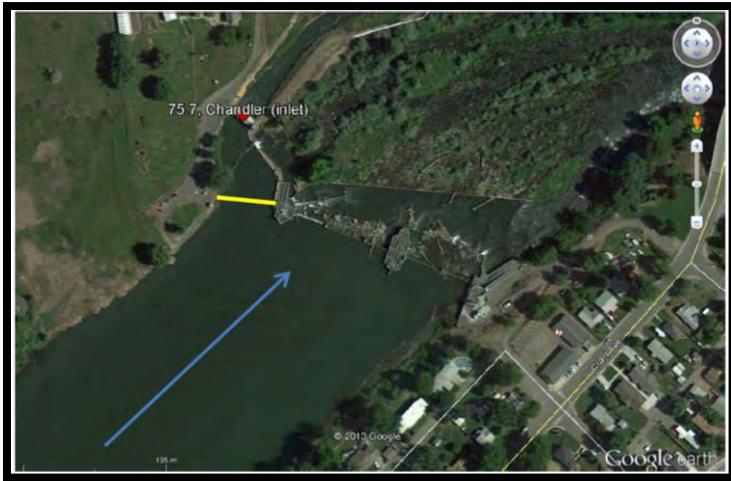
**Figure 6.20.** Chandler (Prosser) Diversion on the Yakima River (inlet angle = 45 degrees, canal width = 11 m). The blue arrow displays the thalweg flow direction and the yellow line displays the general orientation/angle of the headgate structure.

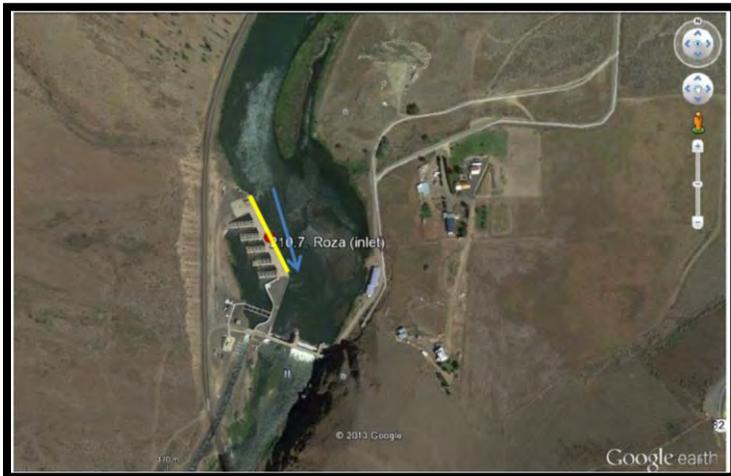
**Figure 6.21.** Roza Diversion on the Yakima River (inlet angle = 80 degrees, canal width = 6 m). The blue arrow displays the thalweg flow direction and the yellow line displays the general orientation/angle of the headgate structure.

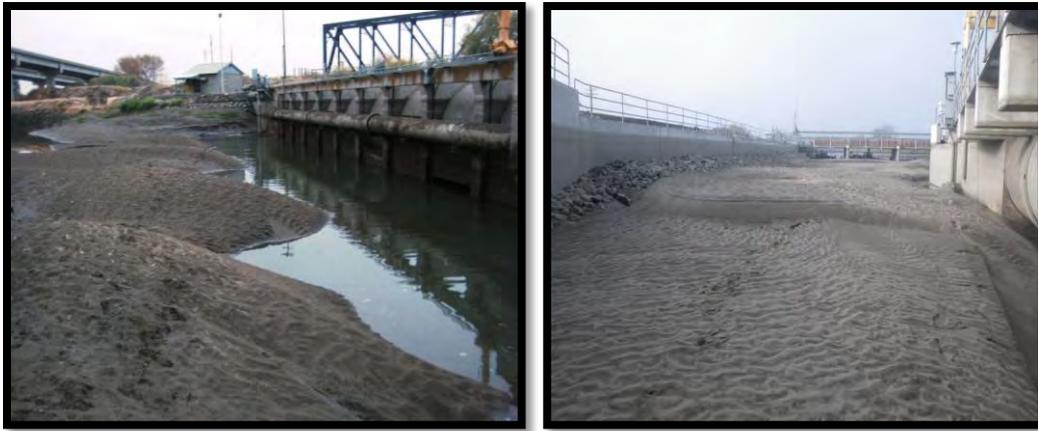
**Figure 6.22.** Examples of diversions with a high accumulation of fine sediment accumulation. Left photo shows the sediment accumulation at Sunnyside Diversion (Yakima River, Union Gap, WA) downstream of the fish screens after dewatering. The right photo shows the built-up of sediment at Chandler Diversion (Lower Yakima River, Prosser, WA) immediately upstream of the fish screens after dewatering.

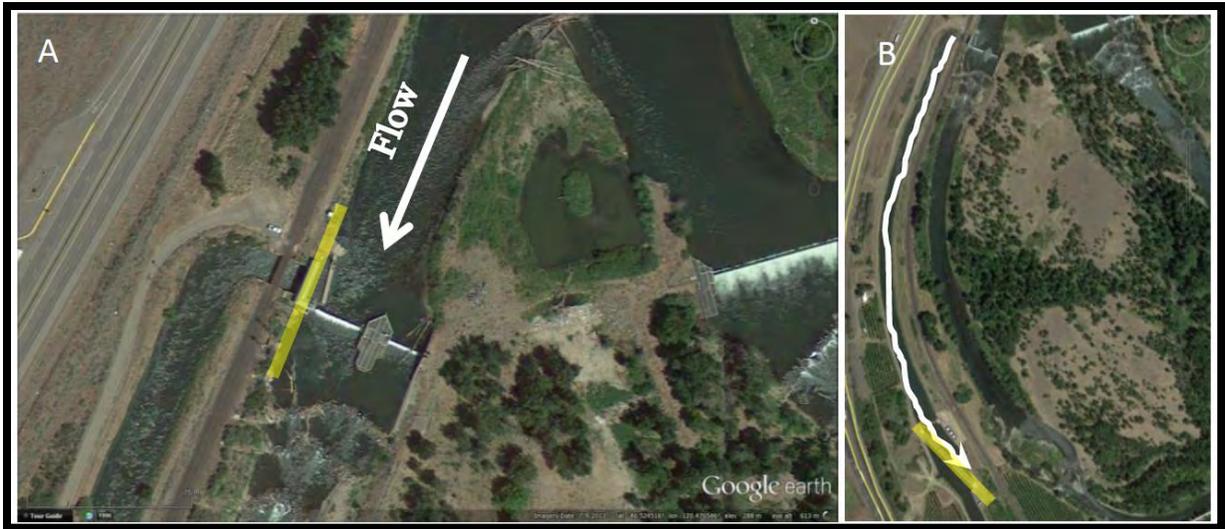
**Figure 6.23.** A) Overview of the inlet to Sunnyside Diversion displaying the orientation of the headgate (yellow) relative to the direction of the main channel flow. B) Overview of the flow direction between the headgate and the fish screens.

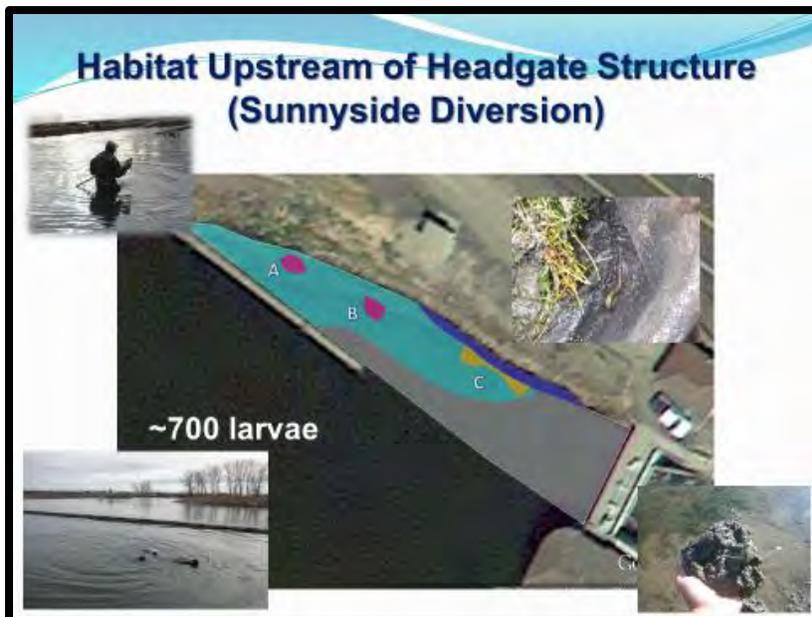
**Figure 6.27.** The area upstream of the Sunnyside Diversion headgate displaying confirmed Type I habitat (light blue polygon), coarse substrate (dark blue polygon), unknown habitat (grey polygon), and dip net survey locations A, B, and C [sites where larvae present (pink) and sites where larvae absent (orange)] on March 3, 2013.

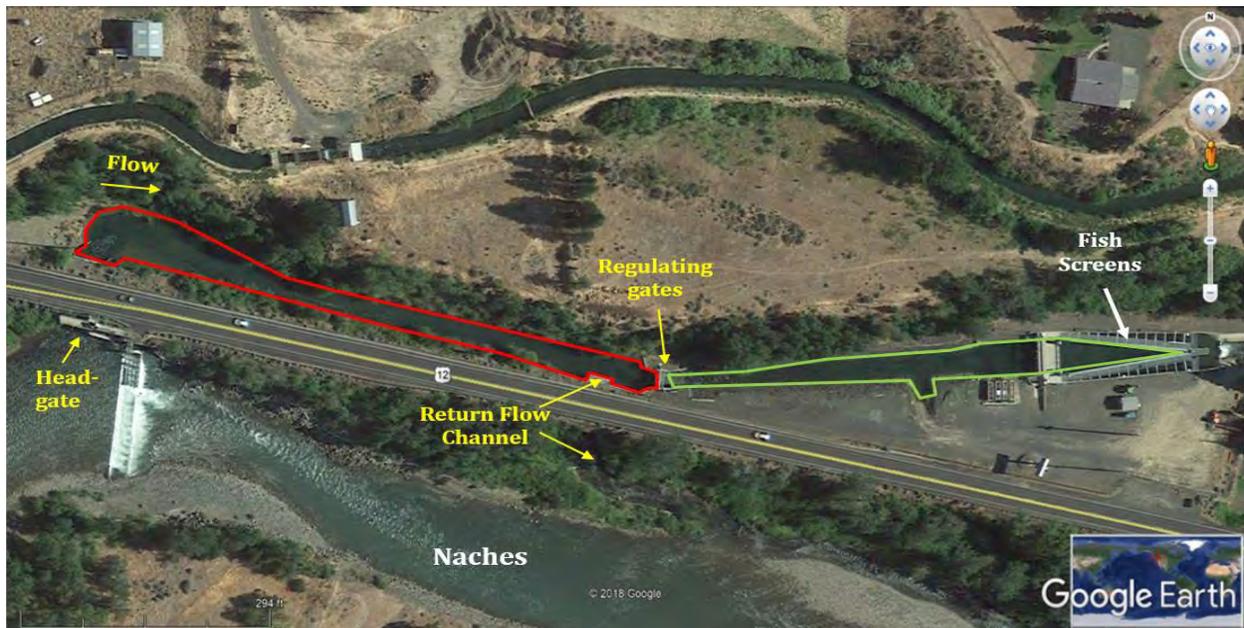
**Figure 6.29.** An overview of Wapatox Diversion, Naches River (water flow from left to right). The area with high densities of larval lampreys is outlined in red. Larval lampreys are found downstream of the regulating gates (green outlined area) near the fish screens, but in significantly lower densities. On November 1, 2018, immediately after irrigation shutdown, the headgates were left open slightly, and flow was provided between the headgates and regulating gates; in previous years this area was left mostly dewatered during the winter months. All winter flow re-entered the river via the return flow channel.

Wapatox Diversion is located in the lower reach of Naches River (headgates at river km 29.0; Fig. 6.29). Wapatox Diversion has a long canal (350 m) between the fish screens and the headgates. There are a set of regulating gates 210 m downstream of the headgates, which during the irrigation season regulate the flow further downstream (Fig. 6.30). Immediately upstream of these regulating gates is a flow return channel, which returns excess flow (and trapped fishes) back to the river (Fig. 6.31). Further downstream (56 m) of the regulating gates are the fish screens and the main fish bypass channel. Annually after dewatering, a high density of lampreys (up to ~50 lampreys/m<sup>2</sup>) and a large area of dewatered larval lamprey habitat (up to ~550 m<sup>2</sup>) are found between the headgates and regulating gates (Fig. 6.32). Past surveys have shown that the majority of lampreys at Wapatox Diversion reside between the headgates and regulating gates with a significantly lesser number found downstream of the regulating gates.

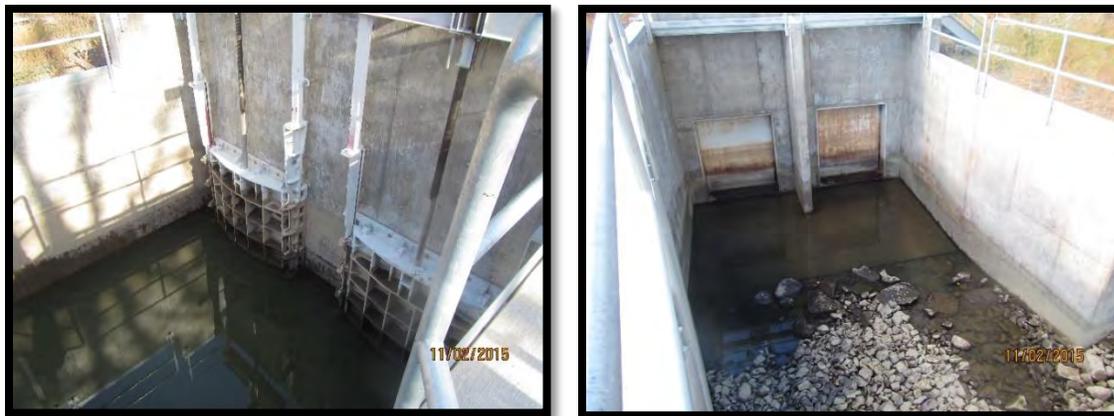
**Figure 6.30.** The regulating gates after dewatering looking downstream (left photo). The regulating gates after dewatering looking upstream (right photo). In 2018, the gates were fully shut after the reopening of the headgates for the winter months. Water level is generally low after irrigation shutdown, limiting potential damages caused by freezing water coming into contact with the gates.

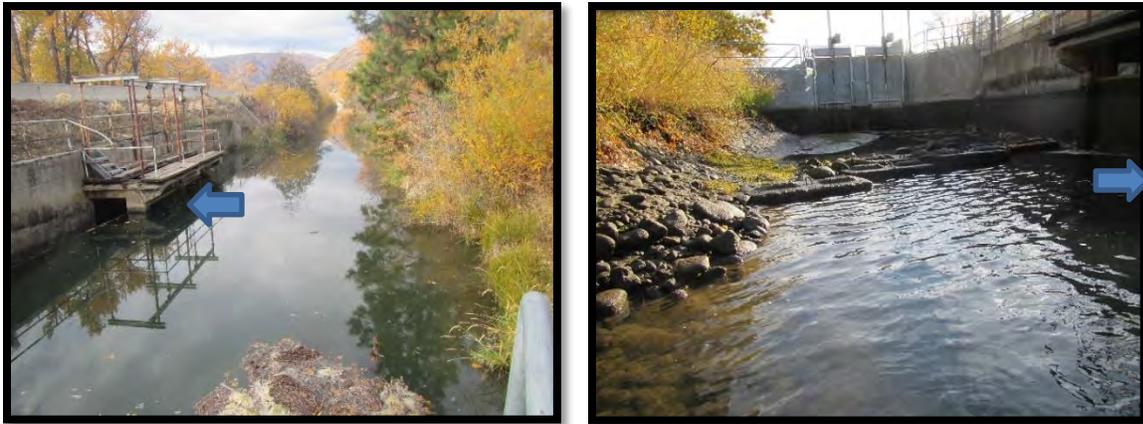
**Figure 6.31.** An overview of the canal between the headgates and the regulating gate looking upstream on November 1, 2018 at 12:05 p.m. (left photo). The area upstream of the regulating gates looking downstream (right photo). The blue arrow in both photos show the location of the return flow channel.

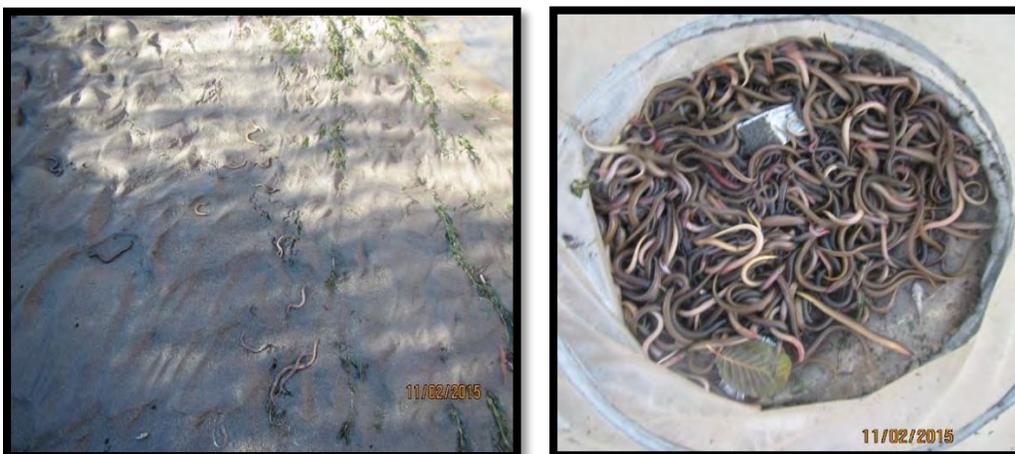
**Figure 6.33.** Larval lampreys collected from dewatered banks at Wapato Diversion in 2015, showing stranded larval lampreys on dry banks shortly after dewatering (left photo) and a collection of many hundreds of larval lampreys from the canal section between the headgates and the regulating gates during electrofishing and bank collection (right photo).

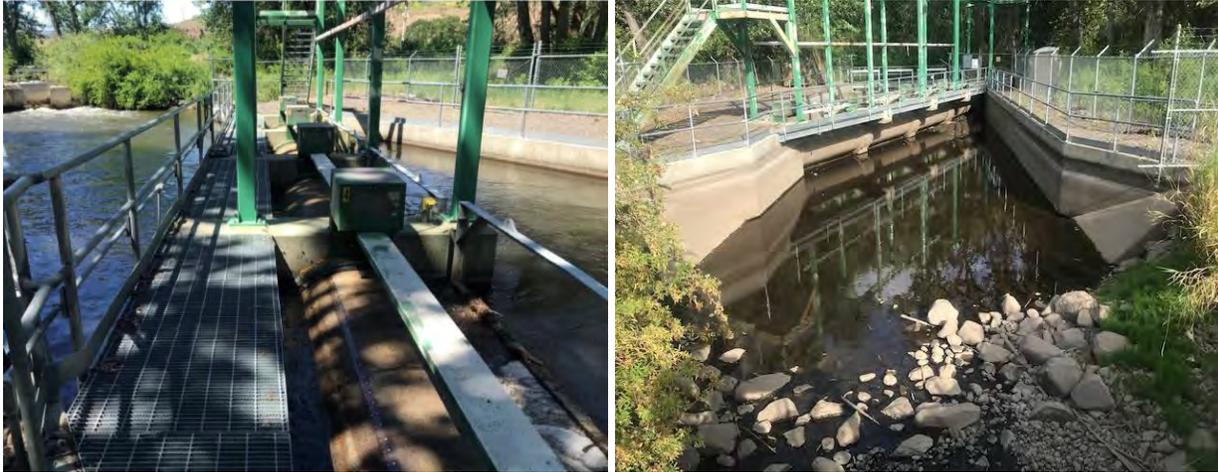
**Figure 6.34.** Overview of Bachelor-Hatton Diversion on Ahtanum Creek. The left photo shows the diversion with water flowing during the irrigation season (flow from left to right). The right photo shows the area upstream of the fish screens after dewatering in July, 2018 (photo taken from the headgate facing downstream).

Bachelor-Hatton Diversion on Ahtanum Creek (near Yakima, WA) is a small irrigation diversion (Fig. 6.34) that has an irrigation season lasting from April 15 through early July each year. The diversion diverts approximately 58 cfs with an average water use of 12,500 acre feet per year. The fish screens consist of rotating drum screens with 1/8” woven wire mesh, which do not meet the current NOAA standards for new fish screens (3/32”) to protect entrainment of salmonid species. The screens did meet the screening criteria during the time of installation. Adult Pacific Lamprey have been released into Ahtanum Creek since 2013 in an effort to restore Pacific Lamprey numbers in the watershed where they were once historically abundant. Both Pacific Lamprey and Western Brook Lamprey (resident species) are present in Ahtanum Creek.

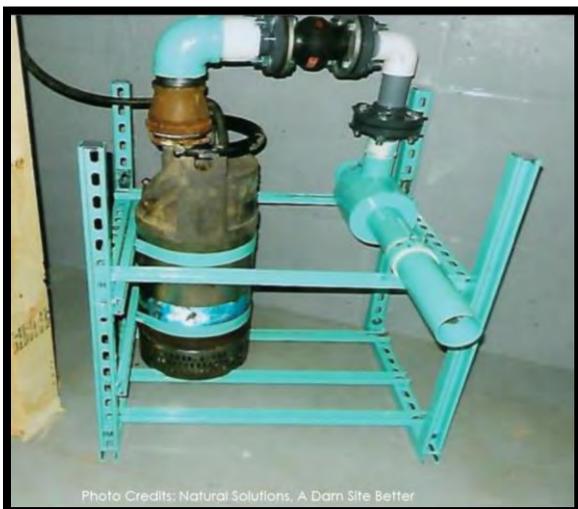
**Figure 6.35.** A Flow Velocity Enhancement System venturi pump similar to the one that will be installed at Bachelor-Hatton Diversion during the 2020 irrigation season, as part of a project funded by the Northwest Power and Conservation Council. Photo provided by Natural Solutions, Helena, MT.

In November, 2018, the Northwest Power and Conservation Council approved funding (\$51,539) for a pilot project using a Flow Velocity Enhancement System (FVES) at Bachelor-Hatton Diversion on Ahtanum Creek (near Yakima, WA). The FVES system is designed and operated by “Natural Solutions-A Dam Site Better!” out of Helena, MT. The system utilizes fish-friendly venturi pumps, which can be used to manipulate sweeping velocities and thalweg flows (Fig. 6.35). The goal of this project is to understand how the FVES unit influences 1) larval lamprey movements into the fish bypass system by increasing the sweeping velocity in front of the fish screens and 2) larval entrainment into the diversion by changing the stream thalweg flow upstream of the headgate to angle away from the diversion inlet (Fig. 6.36). This project will not only allow us to understand the effects that the FVES unit will have on larval entrainment, but also what our released lamprey numbers mean in relation to overall abundance within the stream.

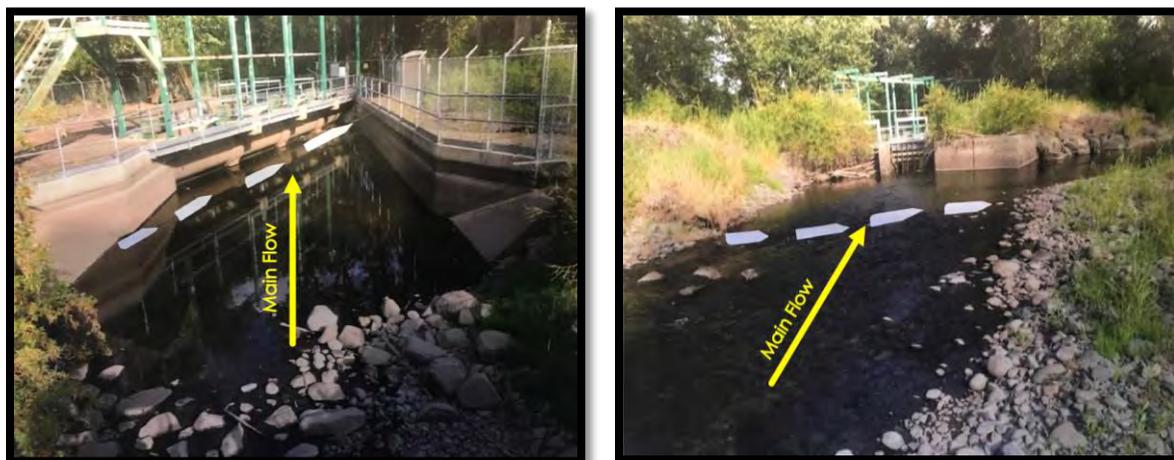
**Figure 6.36.** Overview of the planned placement locations for the FVES units at Bachelor-Hatton Diversion. The left photo shows the thalweg flow (yellow arrow) immediately upstream of the fish screens, and planned directed flow by the FVES unit at this location. The right photo shows the thalweg flow (yellow arrow) immediately upstream of the headgate, and the planned flow direction by the FVES unit at this location.

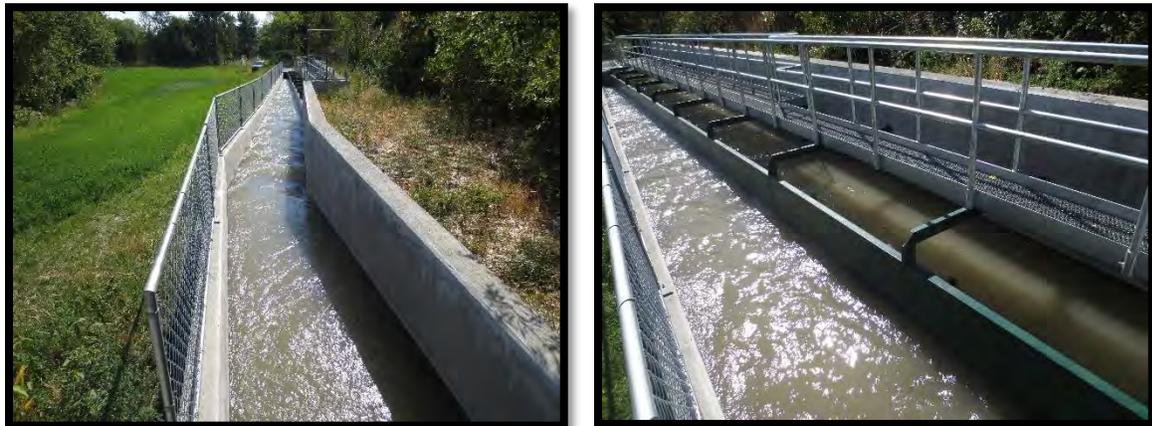
**Figure 7.2.** Overview of Scott Ditch Diversion (Naches River, Naches, WA). Water flow is swift preventing the deposition of fine sediment within the canal. Left photo shows the segment upstream of the bypass area (looking downstream). The right photo shows the downstream end of the screen (the slow water on the right side holds water that moved under the bottom oriented screen).

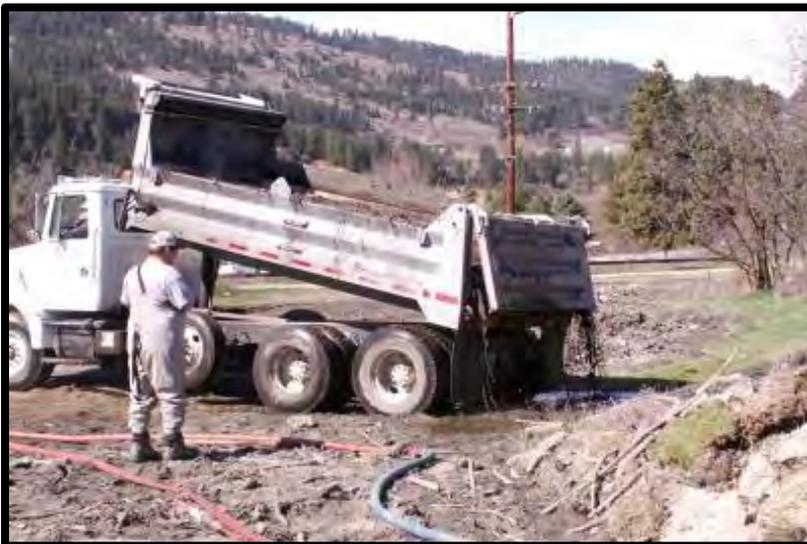
**Figure 7.4.** Lampreys, fine sediment, and accompanying water could be transported in a waterproof dump truck to a nearby refuge release location where they have a chance to settle out (such as side channels, acclimation ponds, etc.) before they move or transferred back to the river/stream.

If there are ideal release locations for both lampreys and the fine sediment they burrow in where they can be transferred from diversions (or dredging project areas), both lampreys and sediment could be dredged and transported to those release locations using waterproof dump trucks (Fig. 7.4; see Task 4.6 and 4.7). If perennial side channels or acclimation ponds are used, this will give a chance for the fine sediment (as well as lampreys) to settle out before they move back to the river/stream (reducing impacts to turbidity). Furthermore, if lampreys could be left in the diversions without any risk of desiccation or the need to be transferred, those options should be pursued. Short- and long-term examples of this was shared in Task 5.3 and 6.10, respectively. If there are ways to allow lampreys to continue to use the refuge habitat provided by the irrigation diversions year around, this is obviously the best solution available (Fig. 7.5).
